RESEARCH AND CONSERVATION TREATMENT OF ROYSTON CAVE, HERTFORDSHIRE: STAGE II

FINAL REPORT FOR THE FRIENDS OF ROYSTON CAVE

MARCH 2014

Report No: RYC01.2 **Date:** 6th March 2014

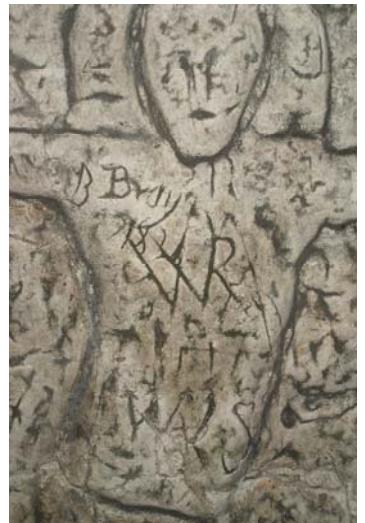
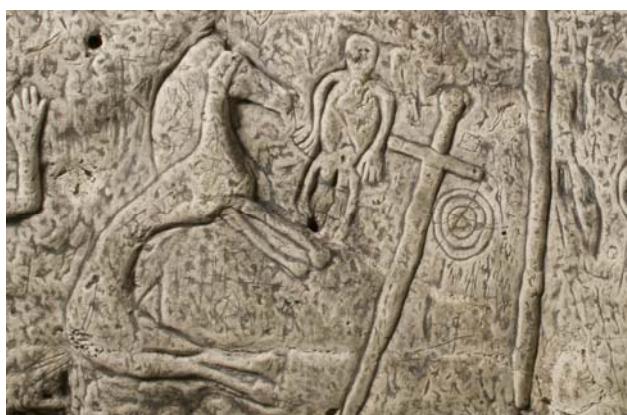
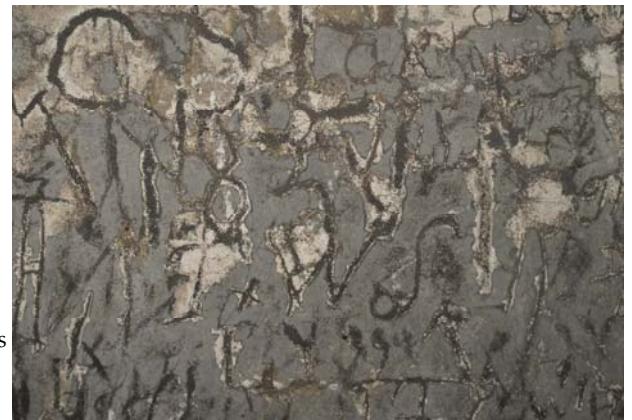
Throughout the cave, there are widespread areas of incised graffiti. The graffiti is concentrated on the lower part of the cave, on and amongst the figures. In many cases, the graffiti included dates from the mid to late 19th century. In addition to graffiti showing text and dates there are a number of incised figurative elements, including hearts within hands, a symbol of charity with Masonic links. In the case of the older graffiti and incisions, the deterioration was such that it was extremely difficult in places to distinguish between original and later incised decoration. It also

Figures 10 & 11 (Below & bottom right) Incisions and graffiti on the figures and background.

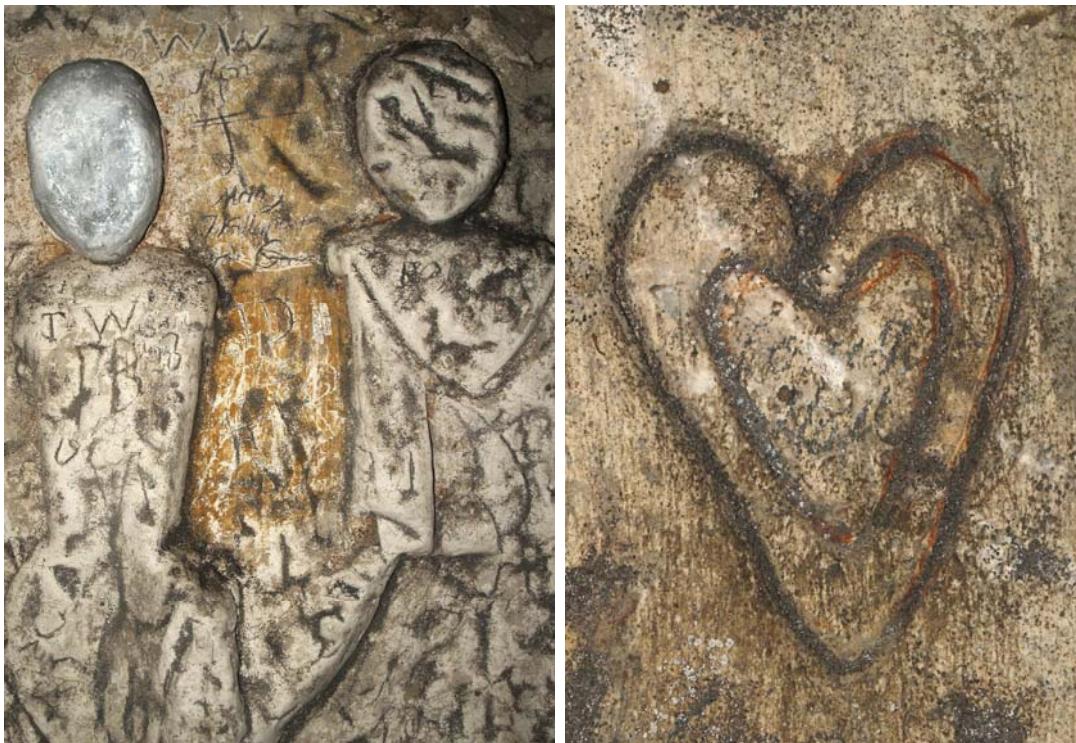
Some polychrome decoration was identified on areas of the carvings, analysis of which indicated the presence of red and yellow ochre. However, there was no evidence to indicate the date of the polychromy and whether it was original or a later addition.

Figures 12 & 13. Pigment on the background of the figures and in the incisions.

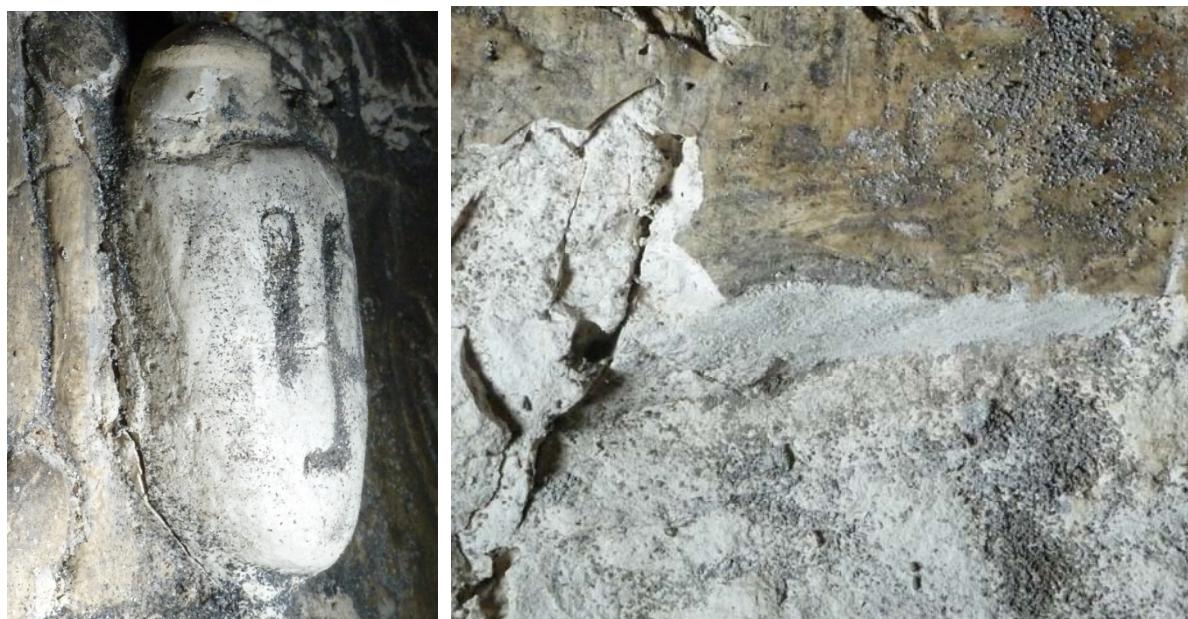
The Stage I condition survey identified a number of fine hairline cracks which had formed behind areas of raised detail (as shown below). This was thought to be an early stage in the delamination process, leading to losses of carved details. In the areas of cracking where the risk of loss was high, remedial conservation treatment was undertaken to stabilise the carving.²⁴ Treatment was undertaken in July 2011 and full details are given in the conservation report in Appendix VI.

Figures 21 & 22. Detail showing the crack between the carved face and chalk substrate behind, and soft hydraulic lime mortar repair.

Carved areas with previous losses, which now had vulnerable edges and surfaces, were treated with small mortar repairs. A number of tests for suitable materials led to the selection of a mortar made from 2:3:3 NHL2 weakly hydraulic lime: marble dust: silver sand. This gave a stable and soft mortar, similar to the chalk material, both visually and in strength. Where coarse damage had occurred to the surface as a result of worm activity, a weak hydraulic lime grout was injected behind flaking areas before a soft hydraulic lime repair was applied. The treatment areas were limited to those areas where the risk of further loss of material was likely to be significant. This has increased the carvings' stability but cannot remove the risk of damage while the underlying causes of deterioration remain.

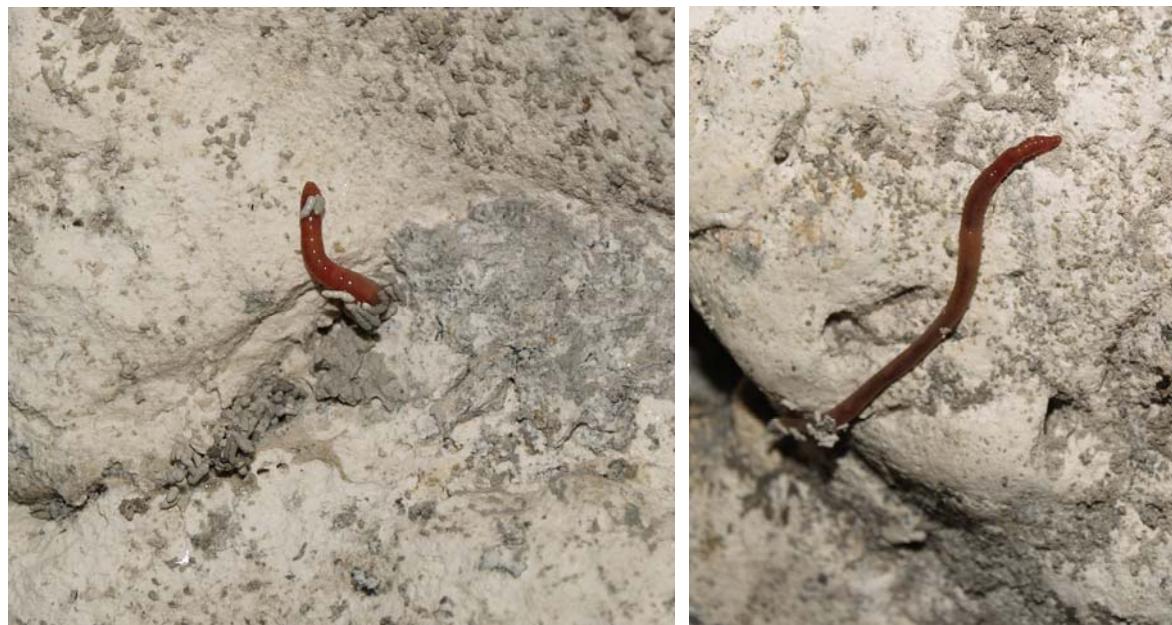
The cave contained both large purple and small translucent worms. The effect of the worm activity is to cause a loss of cohesion and collapse of certain sections of the softer chalk and a consequent loss of the carved detail. The large purple worms measuring less than 40mm in length were identified as *Eisenia fetida*, known by a variety of common names, including the redworm or brandling worm.²⁵ *Dendrodrilus rubidus* was also identified, more commonly referred to as earthworms.²⁶

Figures 21 & 22. Red worms emerging from crack in the chalk. Note the worm casts on the surface.

As a suitable biocide treatment could not be found, it was decided that the most effective method to limit their destructive effect, was to reduce their habitat within the cave and, therefore, reduce the

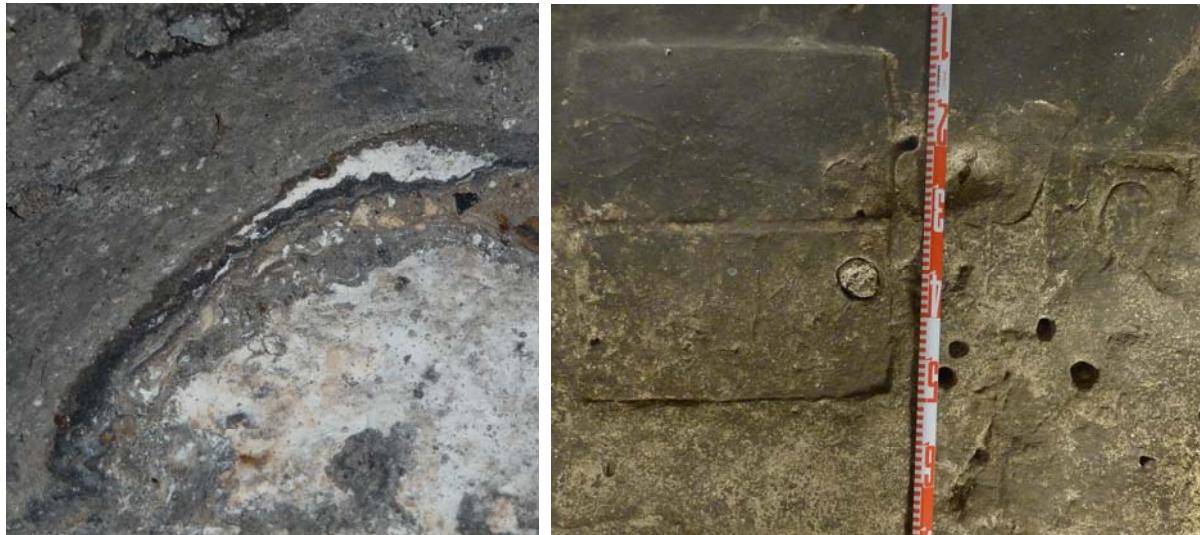
Figures 23 & 24. The compacted soil on the step and the exposed carvings when the soil was removed.

number of worms present. This involved removing the large volumes of soil and other debris that had built up at the base of the cave and, in particular, on the step below the carvings and on the horizontal surfaces in the chalk openings. Large areas of the soil were found to be heavily compacted, although the areas where most worms were found were less so. Tests showed careful mechanical removal was most successful, and was the safest means to remove the soil layer but leave the chalk substrate beneath intact. Material was removed using scalpels, small dental tools and soft brushes, with any residues removed with soft brushes and vacuum cleaners. A number of additional carvings showing lying figures, similar to the 18th century illustrations were revealed by the removal of the soil²⁷.

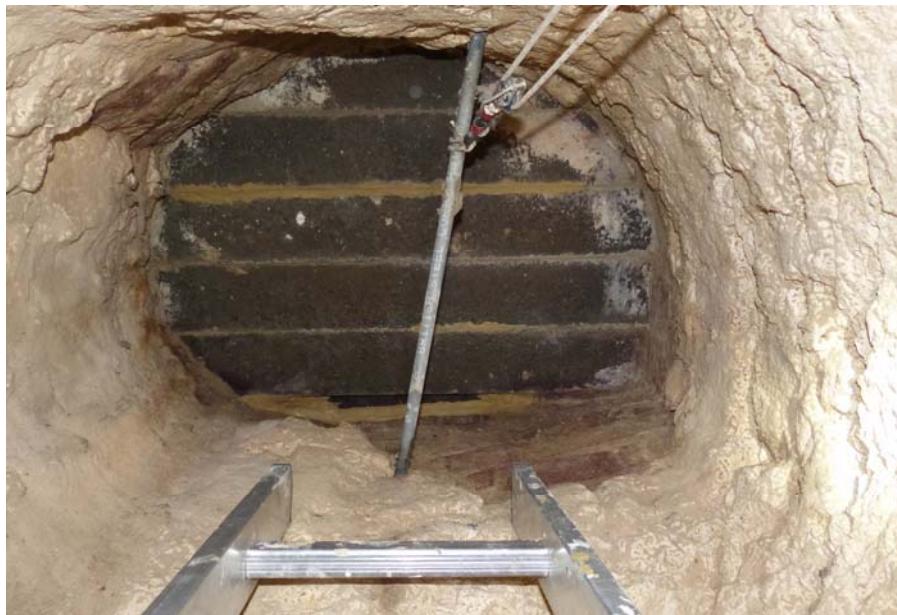
Further worms were observed falling from the east shaft in July 2012. The shaft was examined in October 2012 and the mud and soil containing the worm population were removed. The top of the shaft was found to comprise concrete slabs which had mortar on all except one side. Mortar repairs to the east shaft were made in April 2013 to prevent additional worms entering via this route. While a limited number of worms remain present, the population of the purple worms has been greatly reduced.

Figure 25. Repairs were made to the top of the east shaft in 2013.

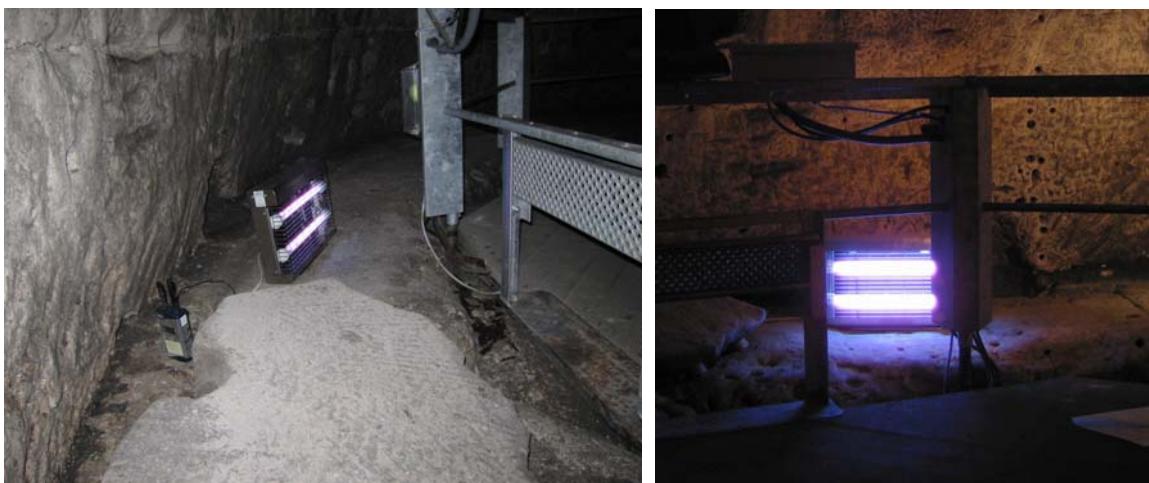
IMSL additionally identified the fly and larvae found in the cave as a type of Fungus Gnat [*Speolepta leptogaster*]. This species is reported to be almost always associated with caves and cave-like habitats. The larvae of this species are thought to have been misidentified as moth larvae previously. Methods were sought to remove these numerous insect pests from the cave, as the larvae stage leave deposits on the surface of the carvings, which are particularly disfiguring.

Figures 25 & 26. Biocide lamp in position.

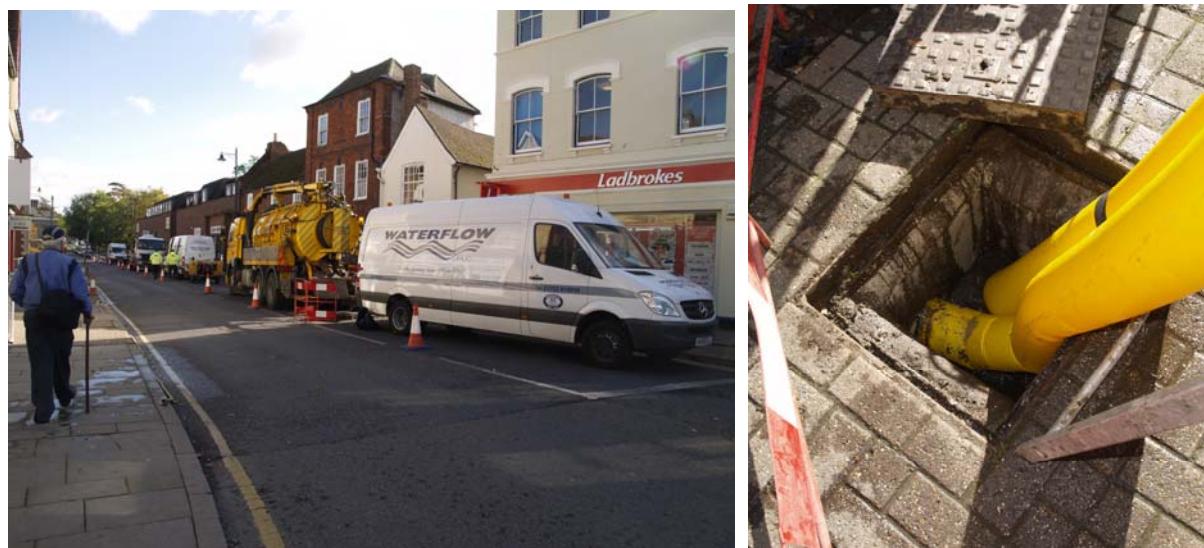
A survey of the drains close to the cave, undertaken in 2009, identified a number of small leaks in both the foul water drainage and surface water drainage that may be leading to water ingress in the cave.³¹ The pipes were cleaned and relined in October 2010, to prevent further sewage or water ingress from these sources.³²

Figures 27 & 28. Repairs being undertaken to the drains in October 2010.

³² Survey and repair works were carried out by Manestream Ltd. The areas of damage to the main drain (center of the road) and the surface water drain (north side of the road) identified in the survey were repaired with resin bonded liners.

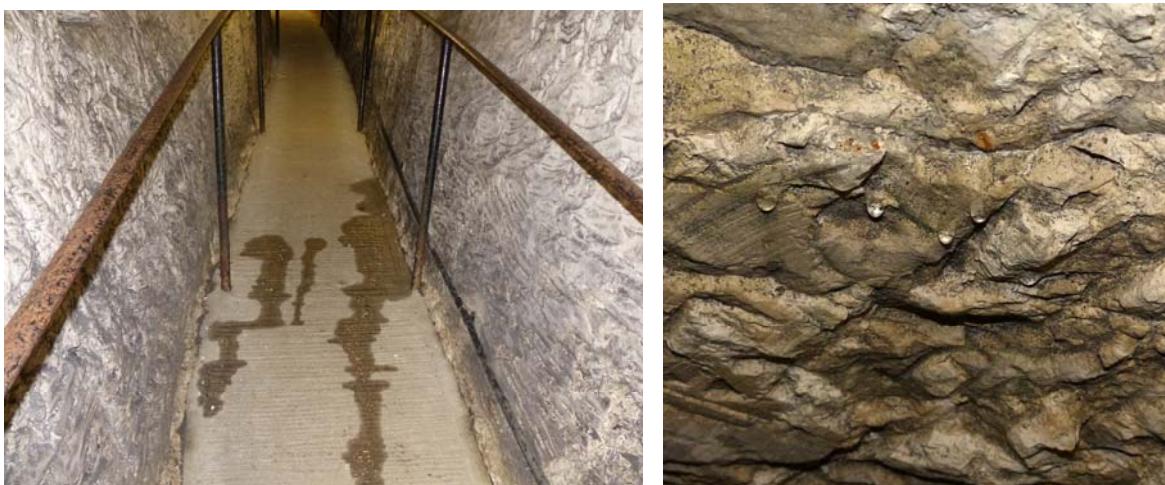
Figures 29 & 30 Water in the tunnel shaft in January 2013.

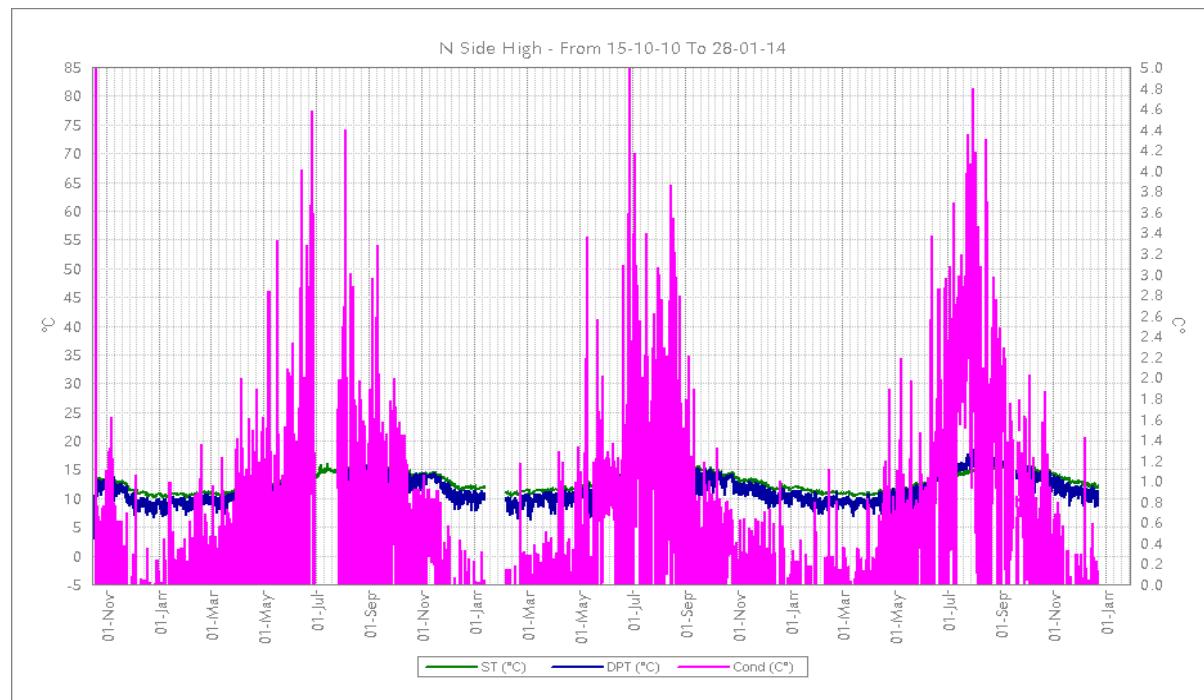
At the higher level of the cave (the surface temperature sensor is at 3.8 m) the risk of condensation in the summer is greater than at the lower level. The high frequency of condensation events means these surfaces may remain wet for extended periods of time, potentially up to 3 months or more.

Figure 37. ST, DPT and condensation data for the higher monitoring position inside the cave (2011-2013).
