CONDITION SURVEY AND DEVELOPMENT OF A CONSERVATION PROGRAMME FOR ROYSTON CAVE, HERTFORDSHIRE

REPORT FOR THE FRIENDS OF ROYSTON CAVE

October 2009

Report No: RYC01.1a

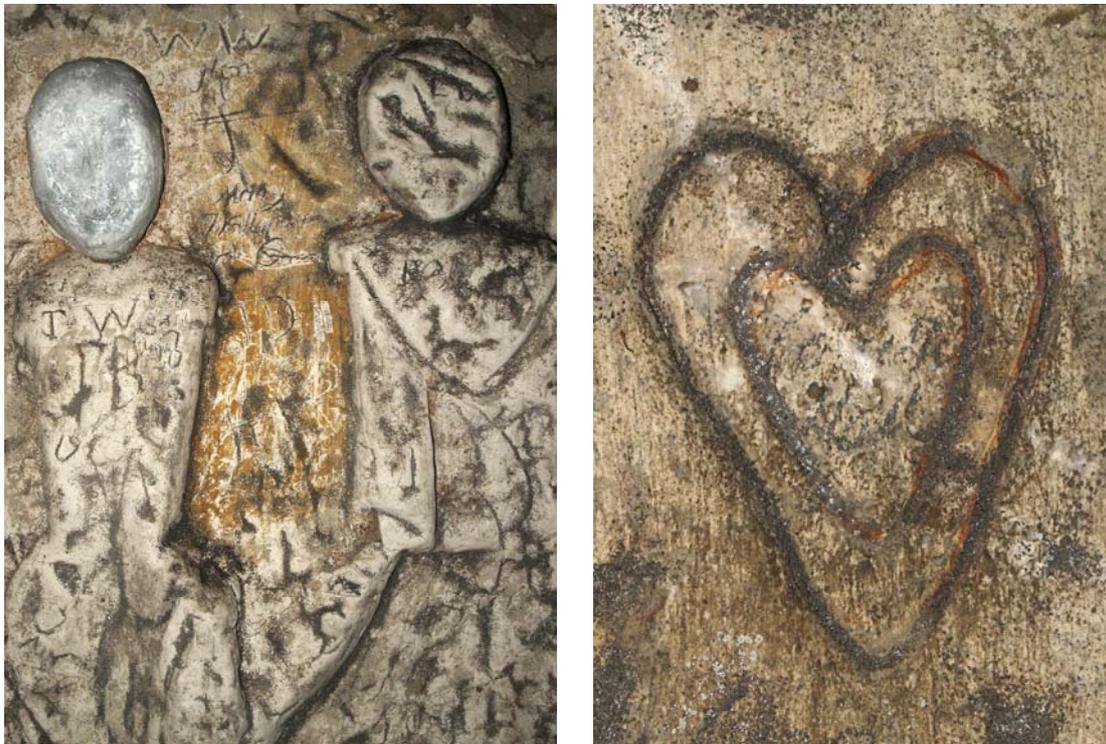
Polychrome decoration was observed in a number of areas, most commonly at low level on the background to the figures, where yellow, or sometimes red, areas of paint were observed. (*Figure 12*) Small fragments were seen on some of the figures, as well as in some of the incisions. (*Figure 13*) There is some debate as to whether the polychromy is original or whether it was applied after the cave was rediscovered. Elemental analysis undertaken in the 1970s showed the presence of chromium (which would suggest a later date) although it is not clear whether this was part of the pigment layer or a contaminant.¹⁰

Analysis undertaken during the current study showed the presence of red and yellow ochre.¹¹ The paint layers were weakly bound and disrupted and there was no physical evidence to indicate whether the pigment was original or applied at a later date. However, the condition of the chalk surface indicates that significant material loss has occurred in most areas. It seems unlikely therefore that original paint would have survived when so much of the chalk did not. It is possible that fragments of pigment interstices may have been protected better, but there is no consistency in different areas. Therefore, it seems likely that much of the polychromy presently visible was applied at a date later than the carvings themselves were made. Whether this occurred in two separate phases (early and late applications) is not apparent from physical evidence.

Figures 12 & 13 (Above) Pigment on the background of the figures and in the incisions.

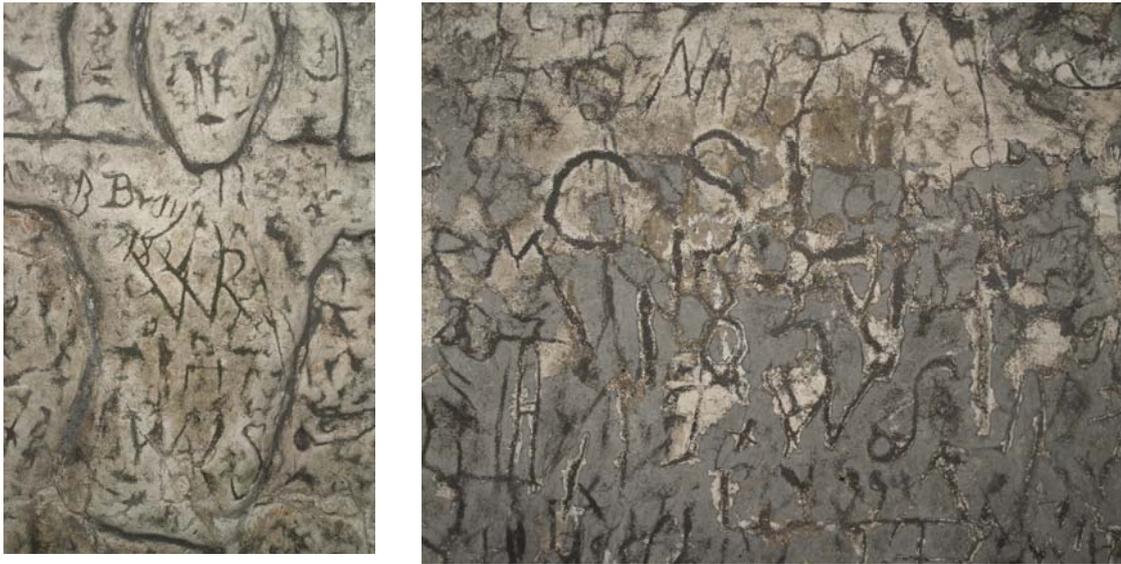
Throughout the cave, there are widespread areas of incised graffiti. By far the largest concentration of graffiti was on the lower part of the cave on and amongst the figures. (*Figure 14*) In many cases, the graffiti included dates from the mid to late 19th century. (*Figure 15*) In addition to graffiti showing text and dates there are a number of incised figurative elements including hearts within hands, a symbol of charity with Masonic links. In the case of the older graffiti and incisions, the deterioration was such that it was extremely difficult in places to distinguish

Figures 14 & 15 (Above) Incisions and graffiti on the figures and background.

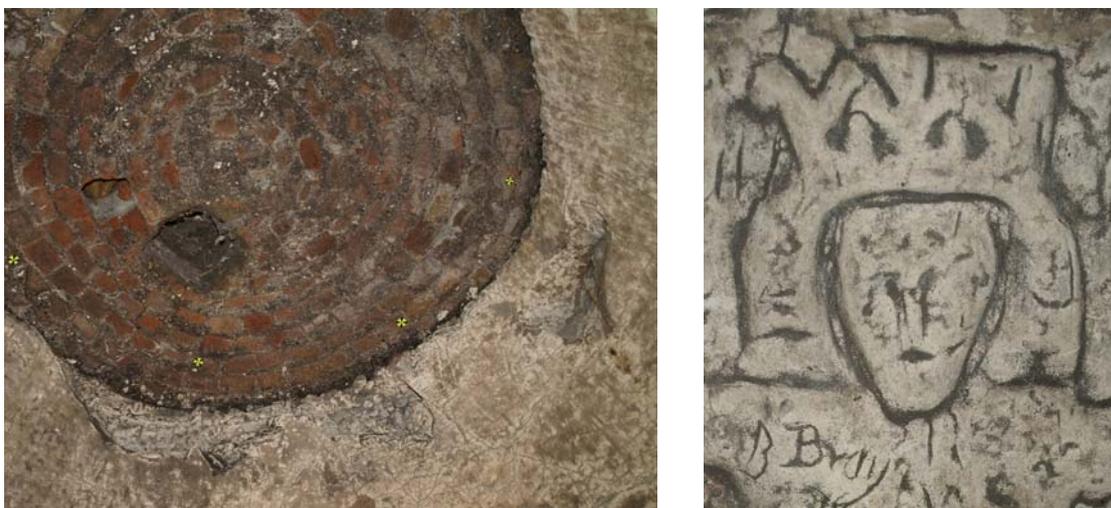
It is understood that the structure of the cave is largely stable.³³ There are some areas where sections of masonry are loose, particularly around the edge of bedding planes higher in the cave, and there are numerous historic cracks, both horizontally along the line of the bedding planes, and vertically up the walls of the cave. However these appear largely to be old, and there is little sign of recent movement. (Figure 20 & Diagrams 1 - 6)

Figure 20. Damage to the upper parts of the walls. **Figure 21,** Deterioration of sharp edges has caused the loss of facial features

Different areas of the cave surface have, at various periods, been cut back to different levels. This is reflected in the varying levels of tool marks which are seen throughout the cave. In all areas, there has been significant loss of fine detail and sharp edges, due to the loss of cohesion and powdering of the chalk surface which has apparently occurred over a long period of time. Therefore, what would have been hard edges and sharp details, all now appear soft and rounded, and in some cases figurative elements are almost entirely lost. This is particularly noticeable with details such as facial features. (Figure 21)

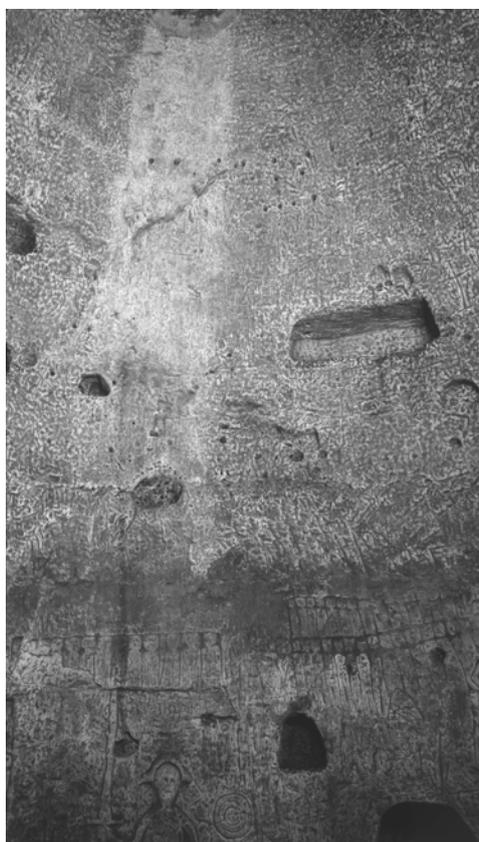
Figure 22. (Left) Washing of the walls below the damage on the north east side.

The upper parts of the wall, beneath the post office cellar damage on the north east side, show signs of long term water infiltration, with hard calcified flakes of chalk on the surface and the soft material washed out behind. A significant proportion of the dirt and worm casts observed elsewhere have been washed down in this area. (Figure 22)

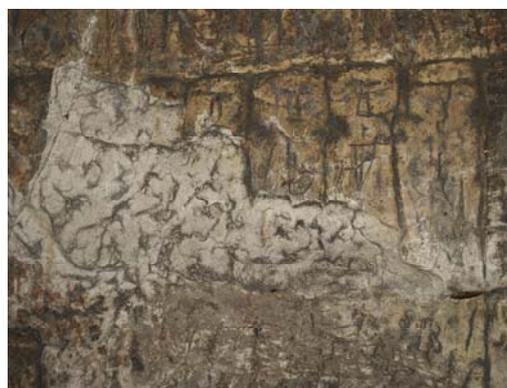
Figure 23. (Right) Loss of a large area of stone above the figure of St George.

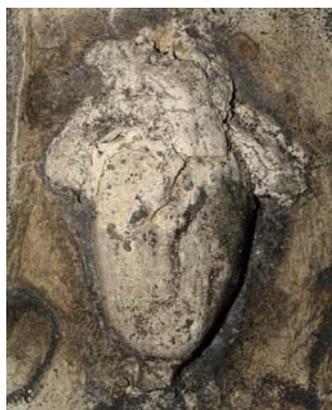
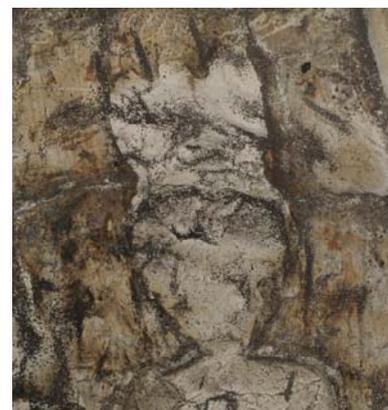
Figures 24 & 25. (Below) Loss of small decorative elements such as heads.

The most serious damage to the carved detail has been caused by delamination and loss of large sections of raised carving. This has tended to occur on the most detailed areas, such as heads and arms, but has also occurred on other areas of background. As a result, losses vary between large flakes of stone, sometimes up to half a metre in length, (Figure 23) to small figurative details. (Figures 24 & 25) The damage appears to have taken place over a considerable period of time, and while some date to the original discovery of the cave, other areas have occurred in the last couple of years.

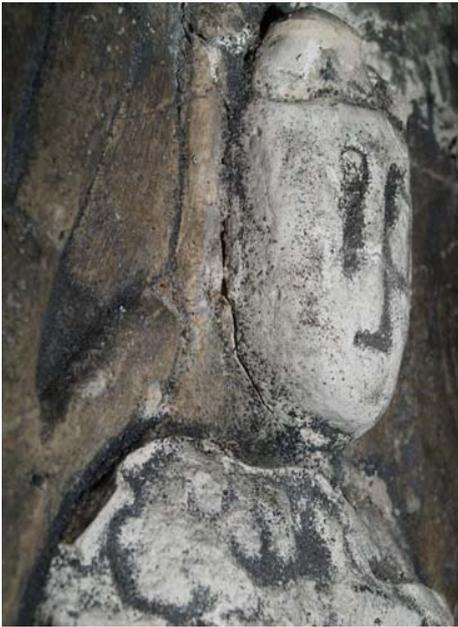
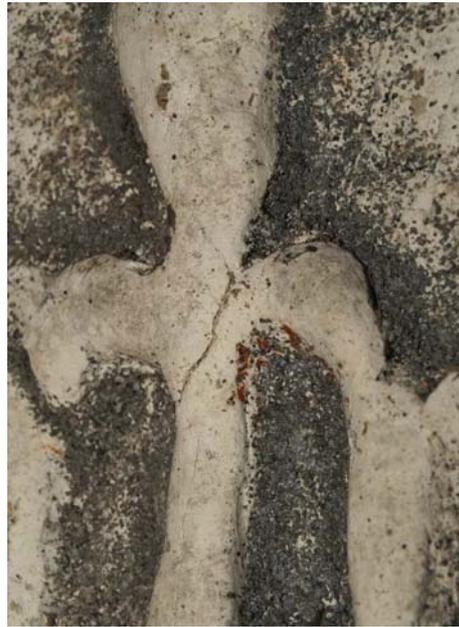
A close examination of the surface in raking light showed that in many areas, fine hairline cracks had opened up behind areas of raised detail, suggesting that the deterioration mechanism is ongoing, and further loss is likely to take place. (Figures 26 & 27)

Figures 26 & 27. (Left) Recent cracking indicating areas of potential loss on the head of St John and the crown of St Catherine.

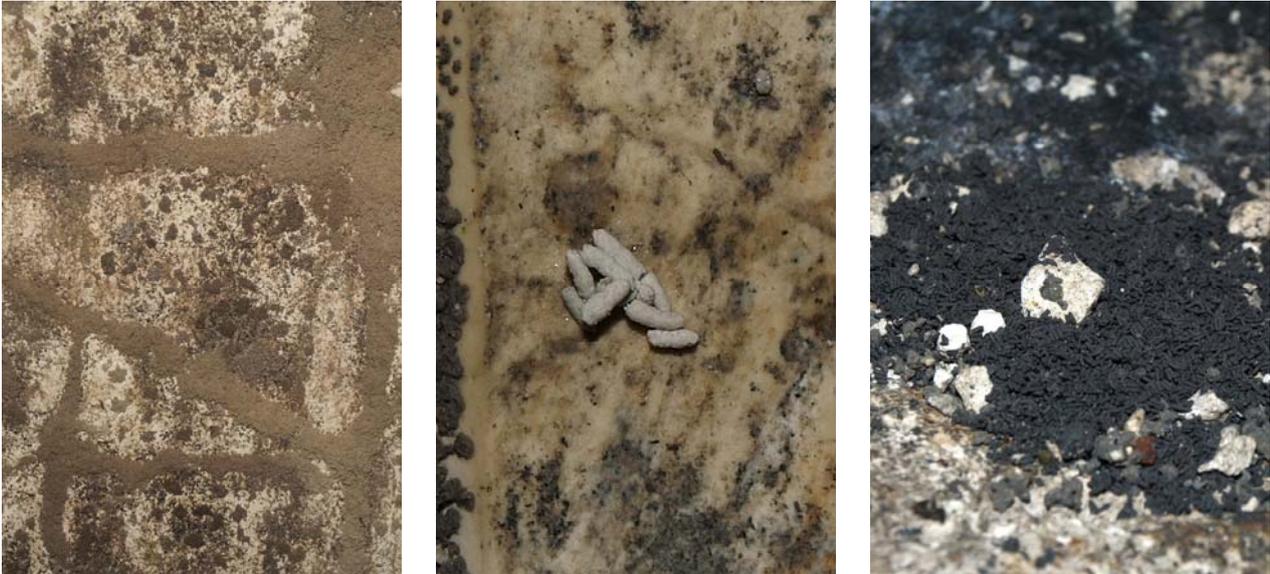
Much of the surface of the cave is covered with fine worm casts. These vary considerably in size and colour. In many areas on the surface of the stone there are deposits of casts less than 1mm in thickness, which accumulate in indents and interstices and are hard to distinguish apart from each other. (Figure 28) In other areas the casts are in small individual groups. (Figure 29) Colours also vary from white to brown and black depending on the location and the material consumed by the worms. On the floor of the cave and on the low step there is a thick accumulation of mud and black worm casts which entirely covers the chalk. (Figure 30)

Figures 28, 29 & 30. Different types and distributions of worm casts on the walls and floor of the cave.

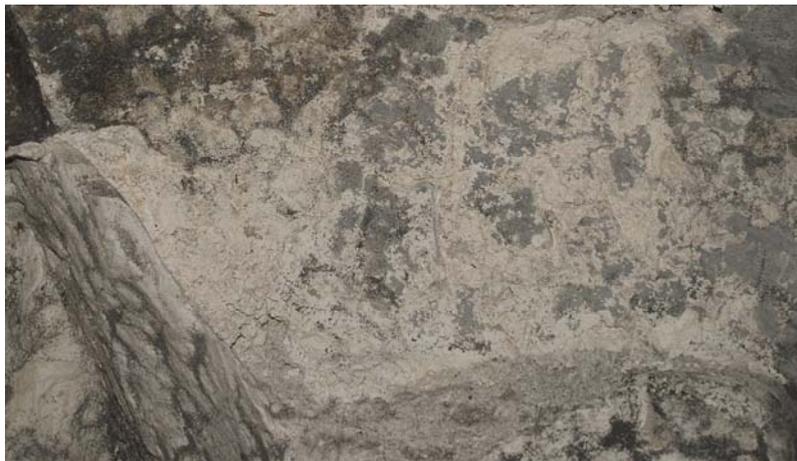
While the accumulation of worm casts is disfiguring, far more serious is the structural damage caused by the worms burrowing through the chalk. This has left some areas with a honeycomb appearance and, in certain sections, has led to the loss of large areas of detail. (*Figure 31*)

Figures 31. Loss of cohesion and detail due to worm damage

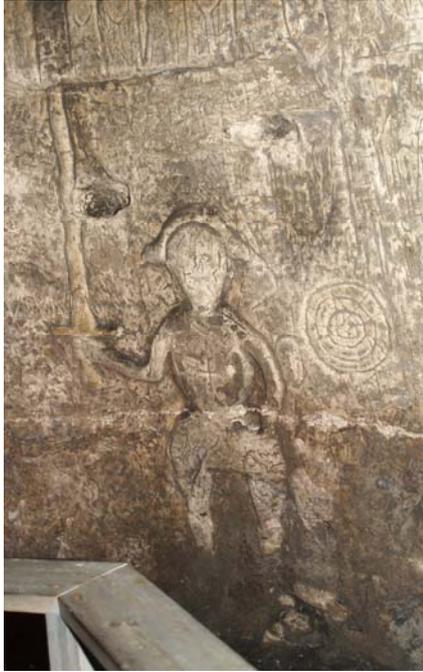
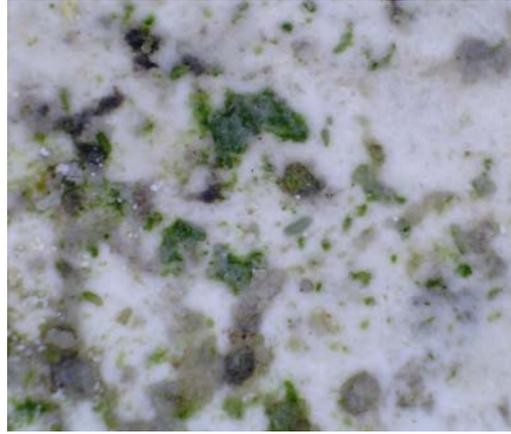
Extensive areas of microbiological growth were observed, mostly on the lower part of the cave. (*Figure 32*) Much of the material is black or brown and is hard to distinguish from the dirt layer which has accumulated on the lower 100cm of the cave walls. Some areas of green growth were also observed, but these are generally small patches distributed over large areas. This was most noticeable on the eastern section by the figure of St George. (*Figure 33*) Green microbiological growth was also observed in the entrance tunnel near to the upper door and the fluorescent lights, indicating the photosynthetic nature of the organisms.

Figures 32 & 33. Small areas of microbiological growing on the lower part of the wall on the east side. (Photomicrograph x200 magnification)

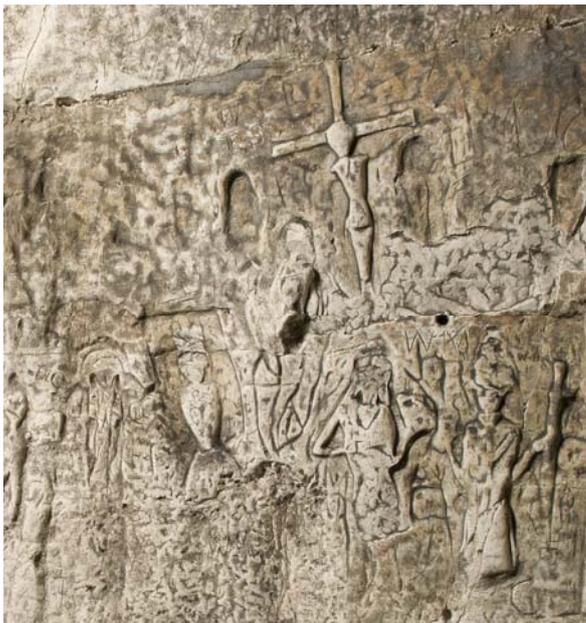
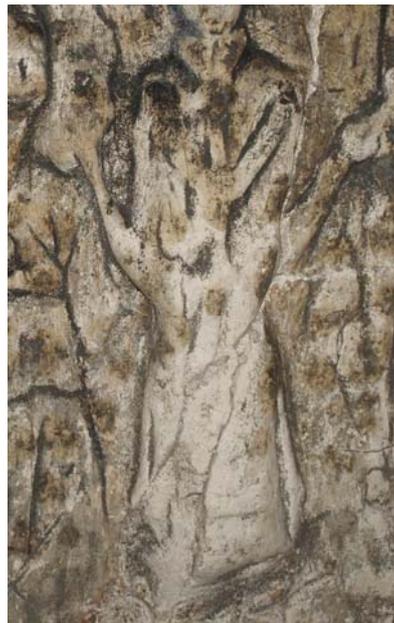
Over much of the east side of the cave there is a brown stain on the chalk and painted surface. (*Figure 34*) (*See Diagrams 1 - 5*) This had previously been thought to be some form of dirt or water staining, particularly as part of it is located below the “post office” damage, where water leakage has been common. In addition, because of the location of the stain low on the wall, it is virtually indistinguishable from the dirt which has accumulated on the base of the wall, which is probably the result of water splashing. (In the diagrams both areas are included, as they are generally impossible to tell apart).

Figures 34 & 35. Brown staining and coating on the east wall. Note the small patches of coating on the robes of the figure of the bishop

However, the nature and distribution in some areas suggests that the staining may, in part, be the remains of an historic coating or consolidant of the type often used in the 19th and early 20th centuries for treating damaged

stonework and wall paintings. (Figure 35) Under UV illumination on site it was found that the coating had a weak greenish fluorescence. However, UV illumination in cross section did not show a discrete coating. Apart from the discolouration, there are no obvious patterns of deterioration associated with this phenomenon and so, at this stage, more in depth investigations of the material are not felt to be necessary.³⁴

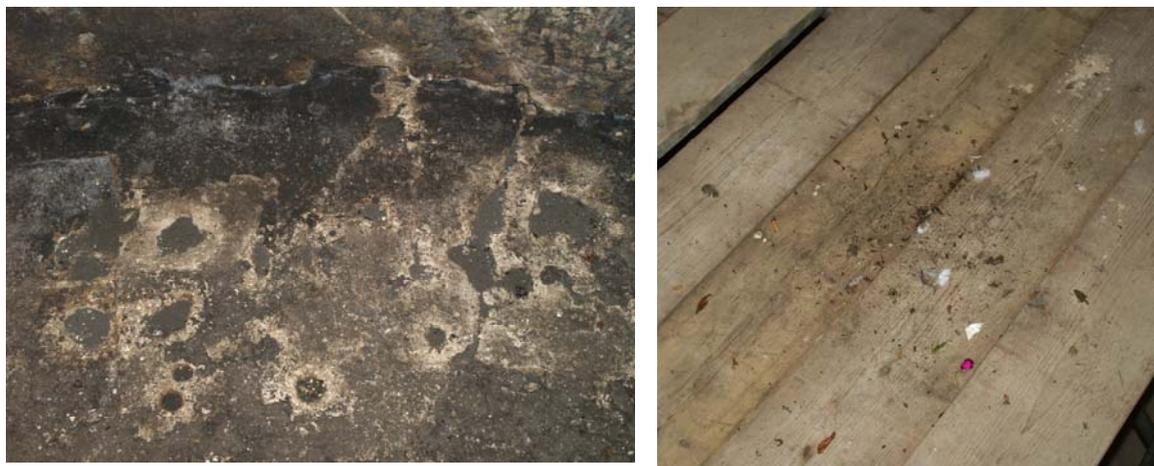
The floor of the cave, as well as protruding sections of carving, are often covered with dirt and debris which has fallen into the cave from the grille in the pavement above. After only a week of the survey, the upper lift of the scaffolding showed a considerable accumulation of debris from this source, clearly demonstrating the volume of material entering the cave via this route. (Figures 36 & 37)

Figures 36 & 37. Accumulated debris and worm casts on the cave step, and the material which fell through the grille onto the scaffolding boards in less than a week.

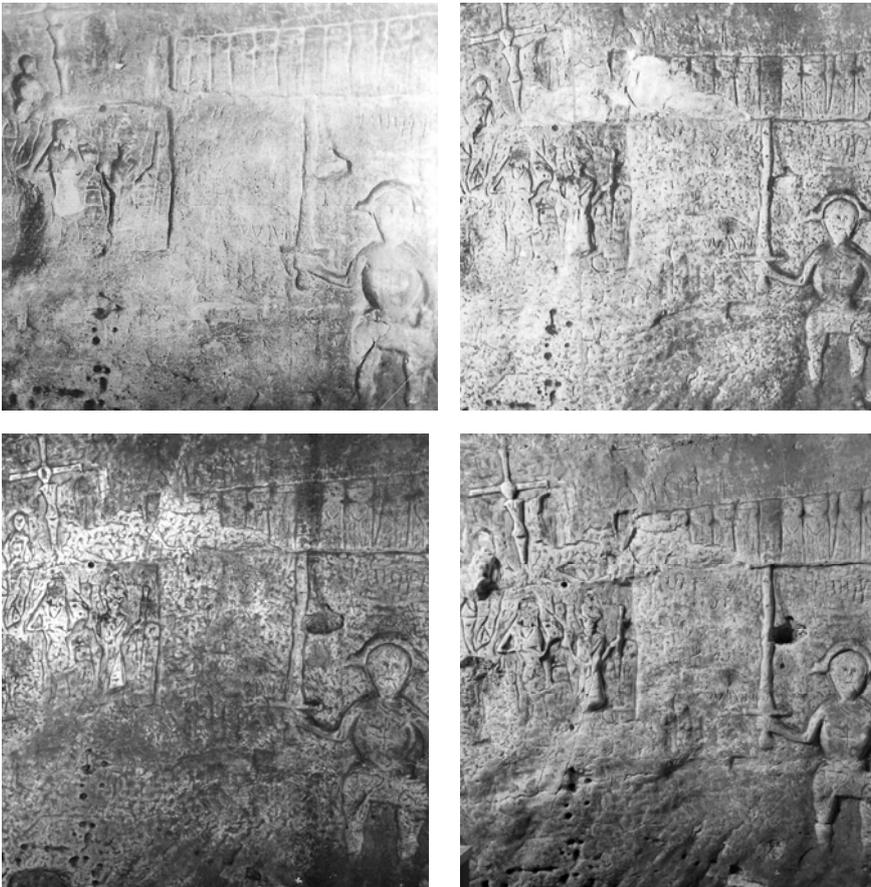
The earliest photographs seen as part of the present survey date to 1911.³⁵ One of the images shows the area to the left of the figure of St George. Here, it is important to note the condition of the small incised figures above the sword of St George. (Figure 38) A photograph of the same area in c.1952 shows very severe loss of a large section of the surface of this area, indicating rapid deterioration. (Figure 39) However, images of the same area in 1997 and 2009 show little change. (Figures 40 & 41)

Figures 38, 39, 40 & 41. (Left to right) Images of the north east side of the cave in 1911, 1952, 1997 and 2009. Note the loss of the large areas of stone on the upper right between 1911 and 1952.

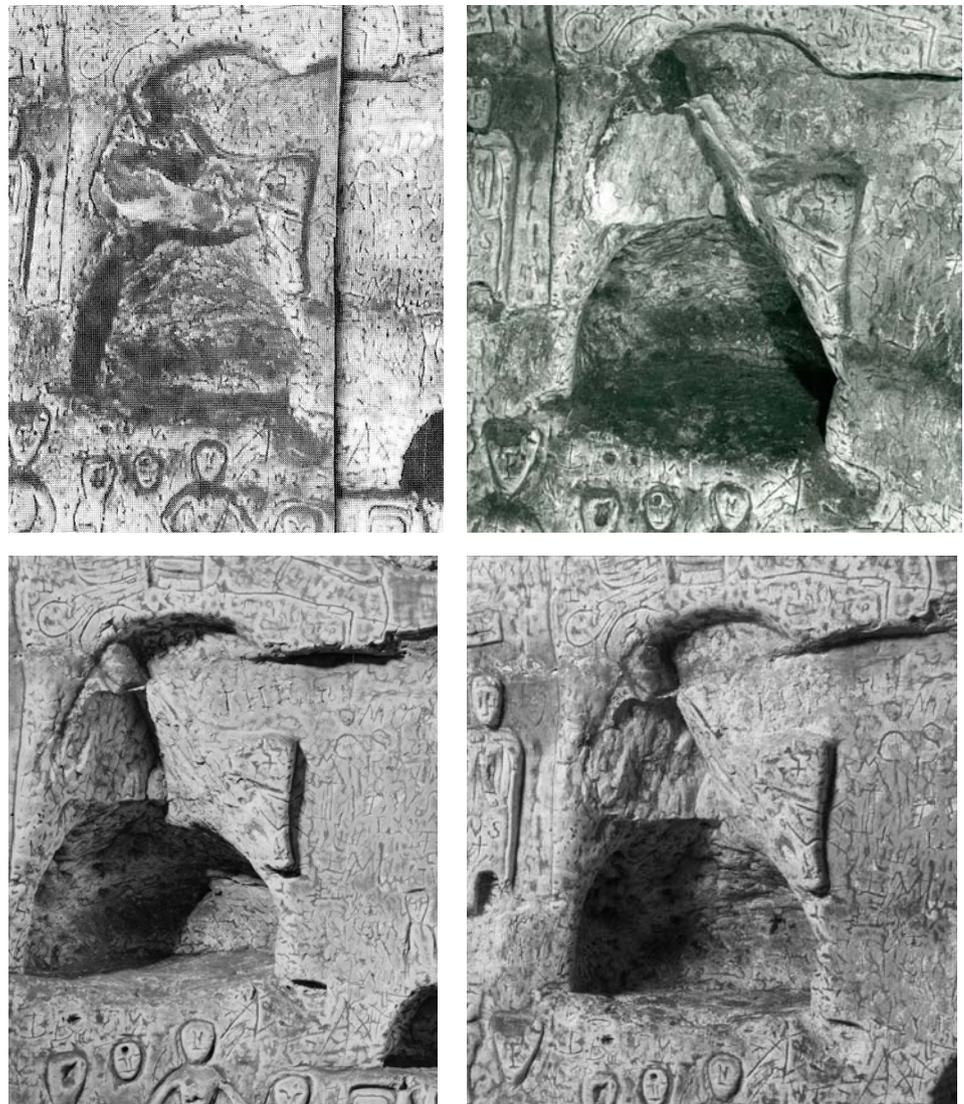
This should not be taken to indicate that serious deterioration in the cave is merely historic. An image in c.1952 of the “Sepulchre “ area on the west side of the cave clearly shows two reclining figures. (Figure 42) When it was photographed in 1973, a large section on the lower left had fallen away, taking with it most of the figures. (Figure 43) In 1997, there had been no further gross deterioration, and the graffiti to the immediate right of the figures was still visible. (Figure 44) However, by 2009, this was almost totally illegible due to worm damage. (Figure 45)

Figures 42, 43, 44 & 45. (left to right) Details of the sepulchre on the SW area of the cave in 1952, 1972, 1997 and 2009. Note the loss of the reclining figures between 1952 and 1972 and the loss of the graffiti between 1997 and 2009.

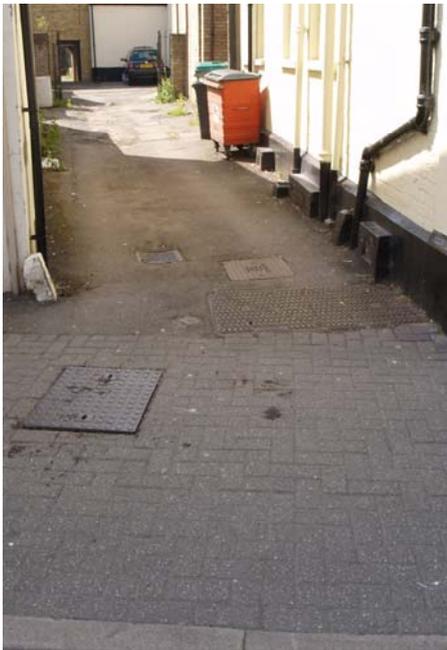
Figure 46. The repaired passageway above the north east side of the cave.

Repairs were made to the drainage pipes and the alleyway was repaired and resurfaced in 2001. (*Figure 46*) Repairs were also made to the damaged area of the wall by the post office cellar, and plastic pipes were installed to throw any continuing leakage water clear of the wall. This appeared to have the desired effect and the level and frequency of flooding was reduced significantly. However, during heavy rain, some flooding is still understood to take place. During the course of the survey, some minor leakage was noted at the top of the ventilation shaft, (*Figure 47*) and during periods of heavy rain, small amounts of water were found to be running down the lower walls of the entrance tunnel. In addition, some rainwater falls through the open pavement grille.

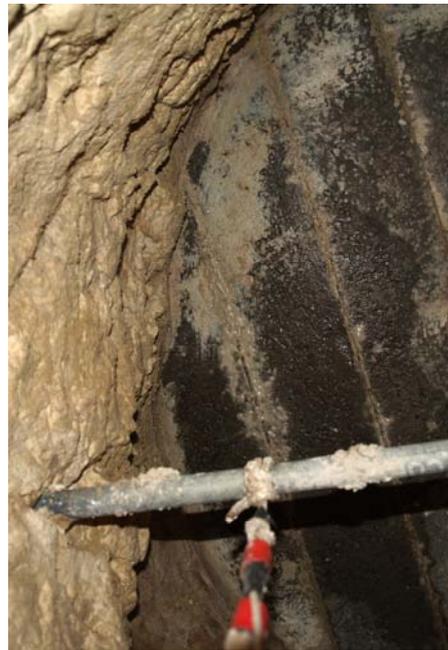
Figure 47. Minor leaks on top of the ventilation shaft.

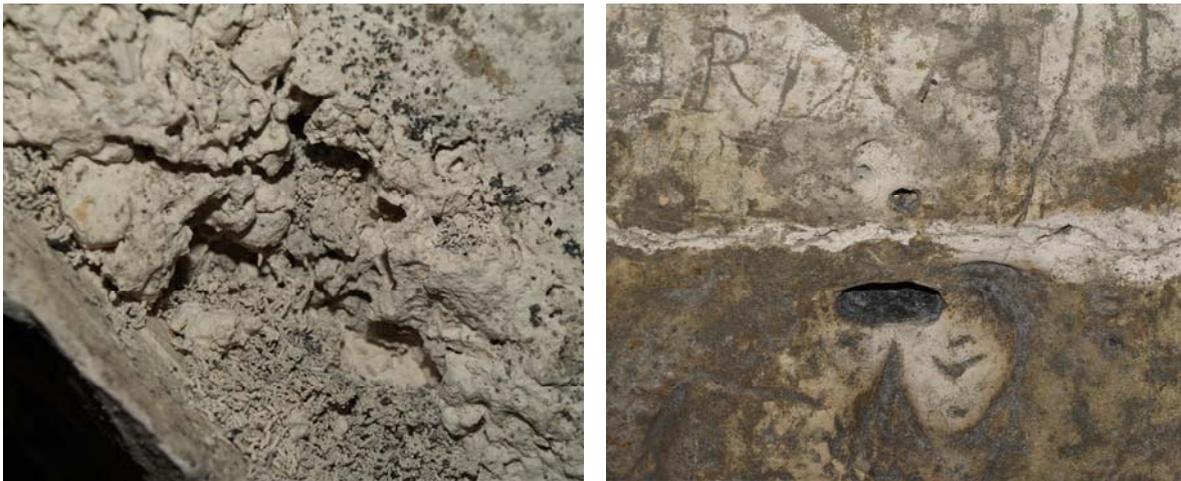
Although the damage is widespread it appears generally to occur in discrete areas, either around bedding plains or on different irregularities in the chalk. (*Figures 51 & 52*) These appear to be areas where the chalk is softer, but they may also have a greater concentration of nutrient contamination from sewage leakage.

Figures 51 & 52. Areas of soft chalk damaged by worm activity.

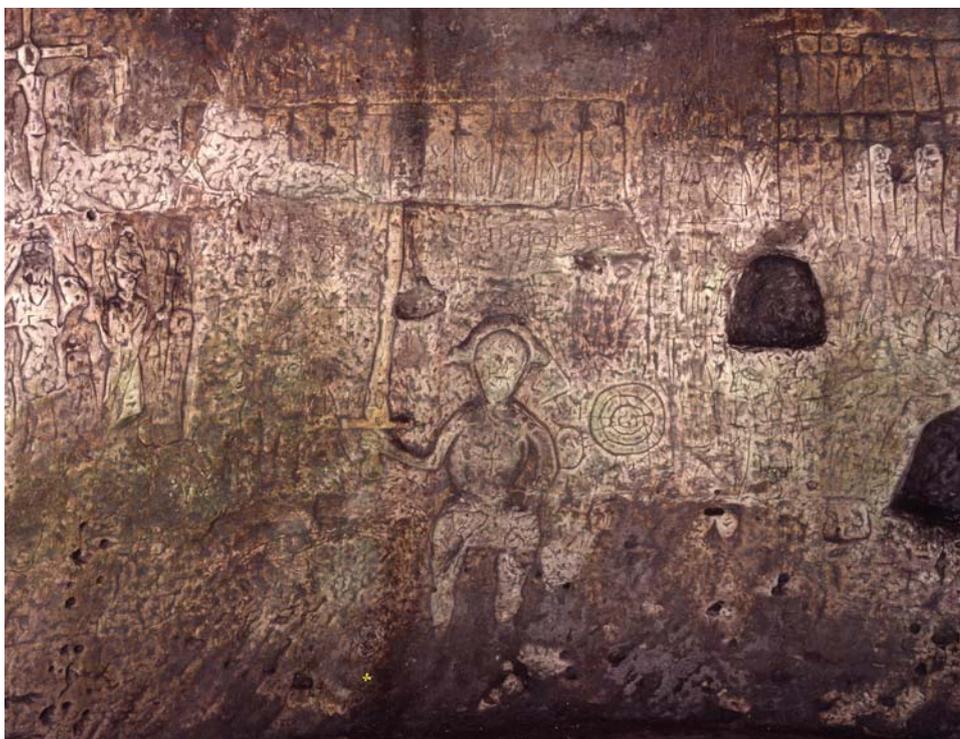
On the lower parts of the walls, there was extensive evidence of algal and other lower plant growth. A survey carried out in 2004, identified *penicillium chrysogenum*, *aspergillus niger* and *trichoderma viride*, as well as mosses, lichens and blue green algae.⁴⁸ This was at its worst during the 1990s, when changes were made to the wiring in the cave and the lights were left on for a long period of time. (Figure 55 & Diagrams 1-5) This allowed the growth of large areas of green microbiological growth in the vicinity of the lights, particularly on the north and east sides, where the flooding had been worst.

Figure 55. Microbiological growth on the east side of the cave in 1997.

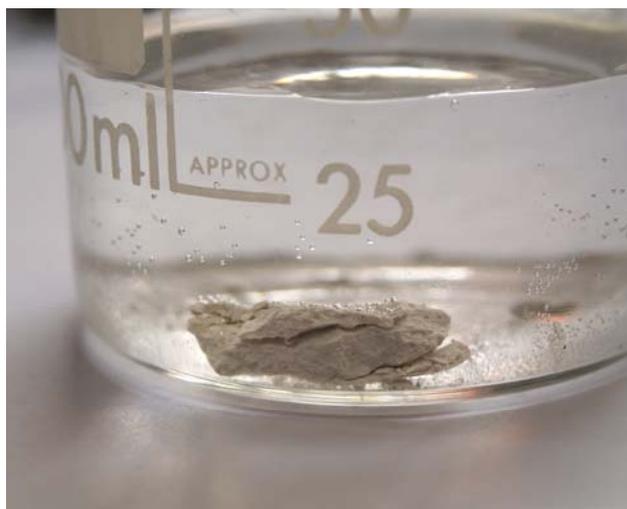
A crude test was undertaken by placing a detached section of chalk from the lower part of the cave in a beaker of water. Within three hours a series of cracks had opened up in the same plane as the surface of the chalk (opposite to the bedding plane). (*Figure 56*) This appeared to suggest that there were interfaces within the chalk which were vulnerable either to the changes in moisture content or to the resulting internal stress.

Figure 56. Cracks in a chalk fragment immersed in water.
