RESEARCH AND CONSERVATION TREATMENT OF ROYSTON CAVE, HERTFORDSHIRE: STAGE II

FINAL REPORT FOR THE FRIENDS OF ROYSTON CAVE

MARCH 2014

Report No: RYC01.2 **Date:** 6th March 2014

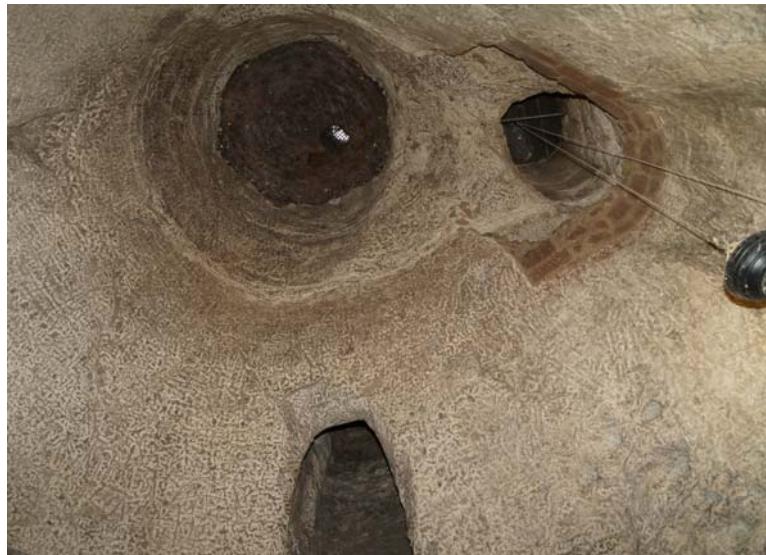
Figure 5. View of and the upper part of the cave showing the bricked up top and opening to the pavement, the partially closed ventilation shaft on the right and the original entrance at the bottom.

smaller shaft that is now closed, with concrete sections at the top, but is thought to have been a ventilation shaft. The lower part of the shaft is built up with carefully cut masonry blocks, some of which have now fallen away.

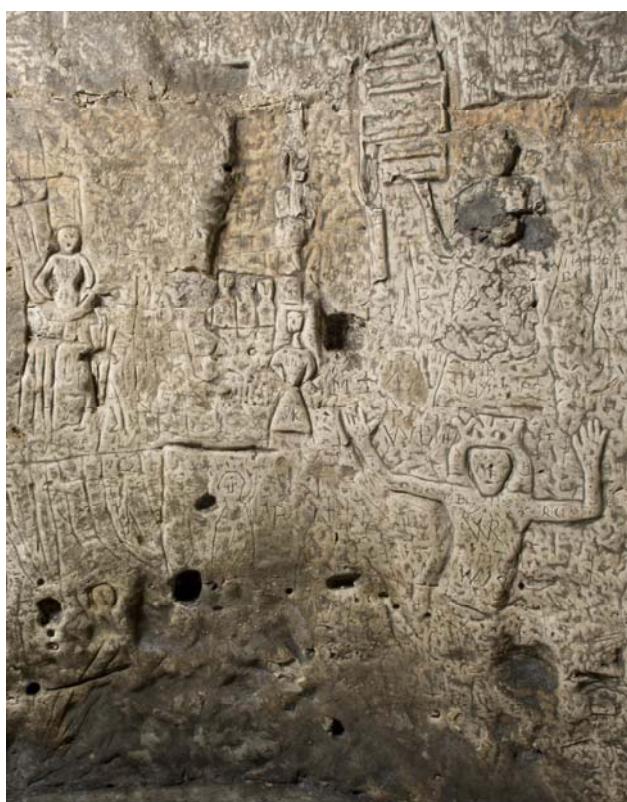
Figures 7, 8 & 9 (Above, left & bottom left) Details of the carvings including St Catherine, the Crucifixion, St Lawrence, the horse and the female fertility symbol.

Figures 10 & 11 (Below & bottom right) Incisions and graffiti on the figures and background.

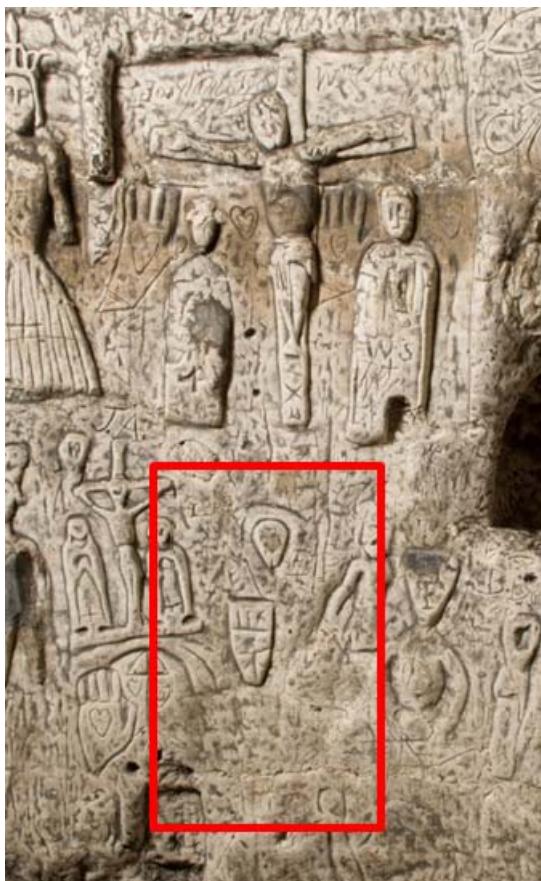
No armour could be clearly identified; however, a number of shields and swords are discussed. Two shields are clearly visible with the oval shaped one bearing no resemblance to known medieval shields. The second, which appears to be associated, with the head above is described as a more conventionally 'heater' shaped shield with decorative incised lines. Previous authors have interpreted these lines as bearing a coat of arms or letters, but these are not sufficiently clear in the images to confirm. However this shape of shield is reported to date from any time during or immediately after the 13th century.

Figure 14. Detail of the carvings showing the 'heater' shaped shield with decorative incised lines.

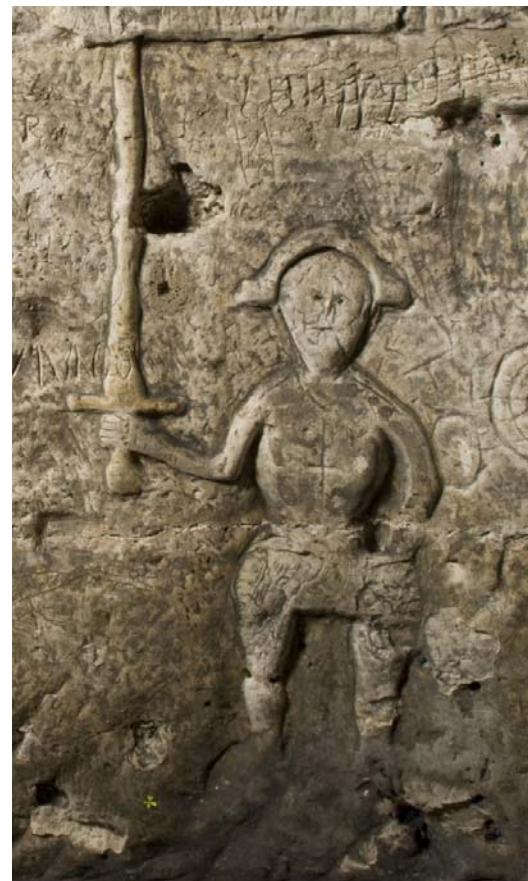
Figure 15. Figure holding a sword with a possible small oval shield on the opposite elbow.

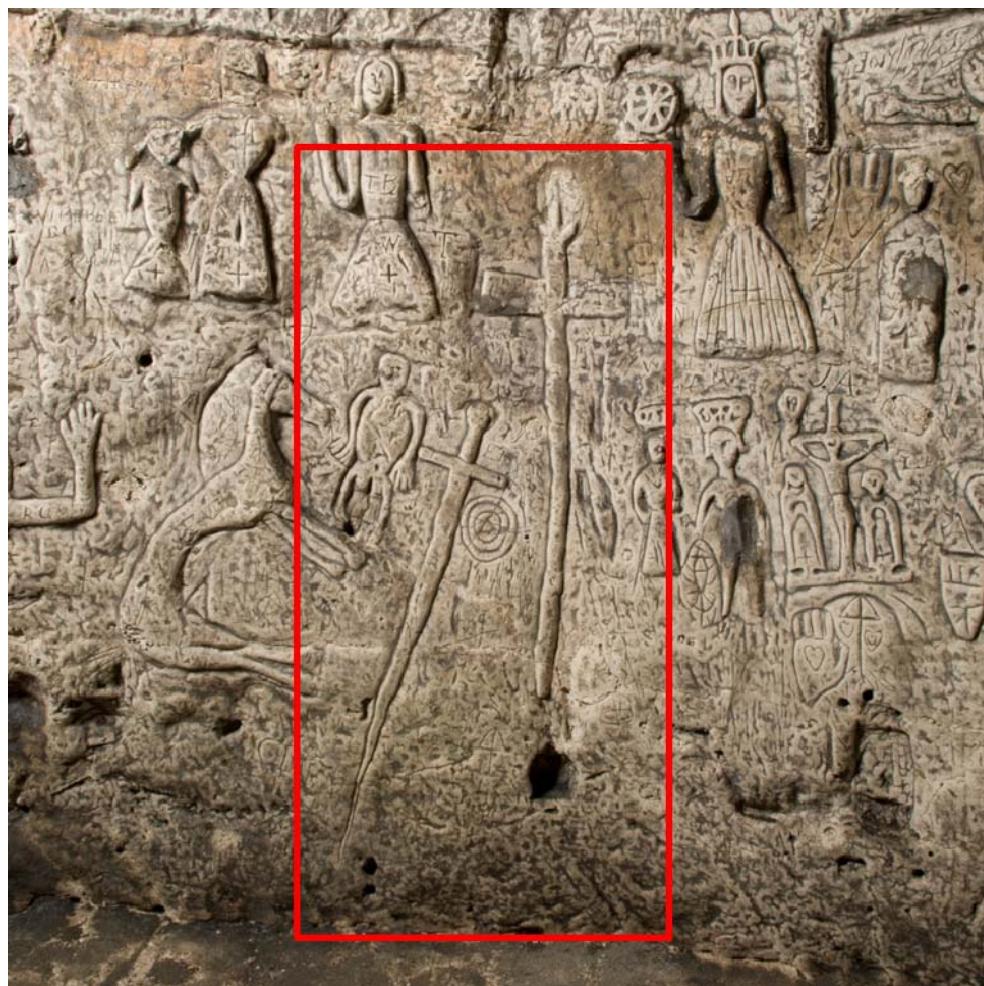
Two definite swords and one possible sword were identified, including the one in the figure above. However, the author notes that dating medieval swords is often difficult as the general form changed relatively little and variations were often used alongside each other for many years. No distinguishing features were found which would help identify the above photographed example, or the identified possible sword, the vertical sword in the red box in the figure below. The other diagonal sword, closer to the horse, has a tapering blade and is suggested to date from circa 1350.

Figure 16. Detail showing swords inside the red box with one possible round shield containing the concentric rings. To the right of the red box are the pair of figures with crowns and St Catherine, with a crown, is at the top right hand corner of the red box.

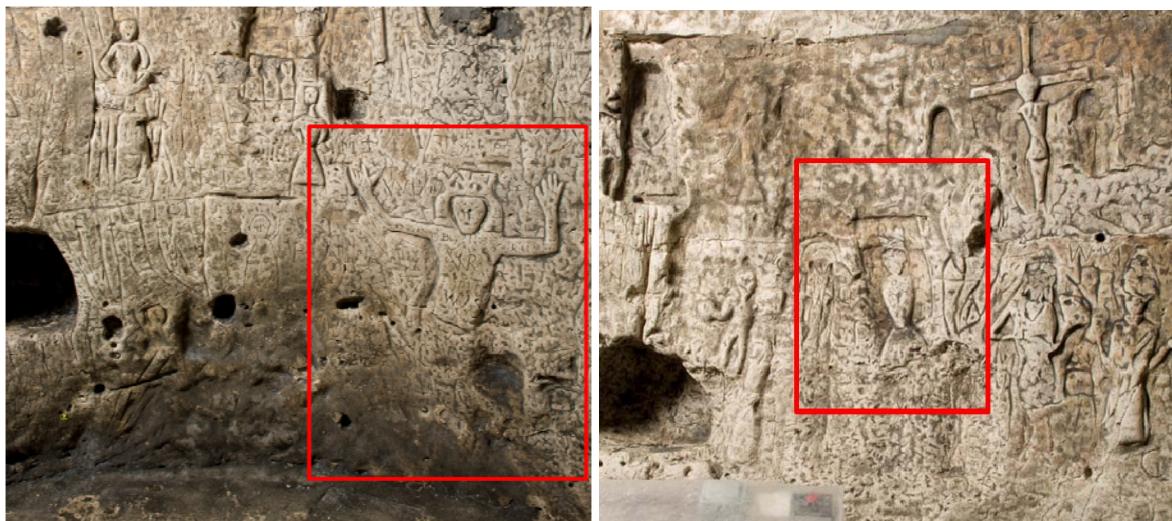
A number of crowns were also identified, including a pair of crowns just to the right of the vertical cross above and that of St Catherine, along with some further possible crowns (shown below). The pair of crowns was thought to represent three tall fleurs-de-lis intersected by two smaller, lower trefoils, found on English coins after 1300. St Catherine's crown does not resemble a medieval crown, but is thought to be an inaccurately drawn version of the pair of crowns design. The additional identified possible crowns do not have dating features or are too deteriorated for any to be distinguished. Based on the arches joining the uprights on the pair of crowns and, assuming St Catherine's crown was derived from similarly designed badges, they are unlikely to date from before circa 1350.

Figures 17 & 18. Details of the carvings showing the further possible crown images.

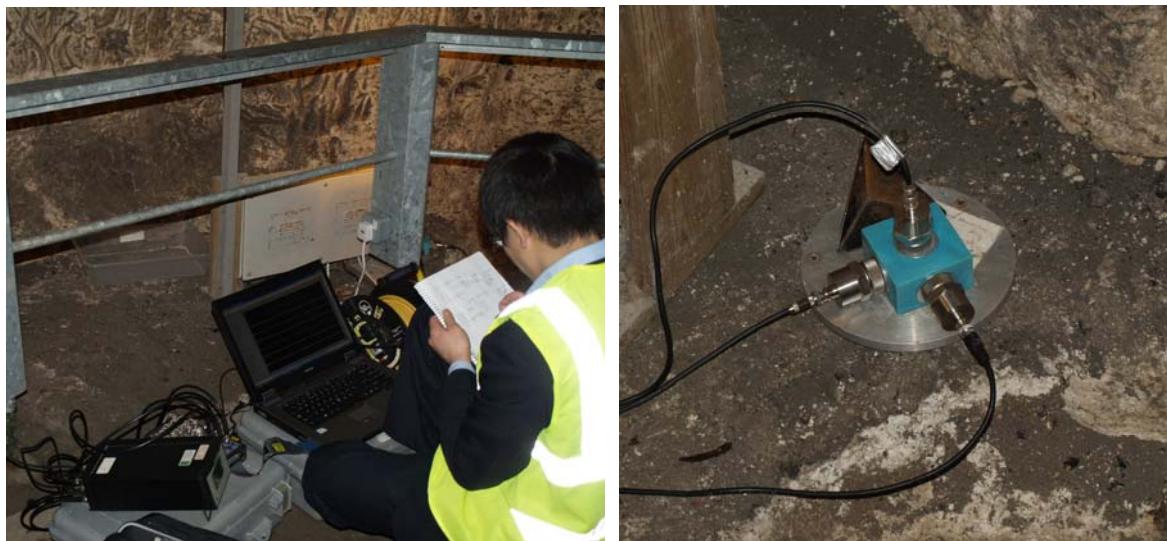
The vibration monitoring recorded low levels of background traffic, with higher peaks (up to 0.05 mms^{-1}) when heavy goods vehicles, buses or tractors pass overhead, or stop at the nearby traffic lights. Tests inside the cave showed vibration levels from heel stamps on the wooden deck were significantly reduced compared to those on the chalk surface. The vibrations from people walking on the wooden deck were lower and did not show up above the traffic vibrations. Therefore, it was concluded that visitor related vibration has little effect on the inner cave surfaces. Both the traffic and vibration levels are reported to be insignificant and not contributing to damage mechanisms. A much higher level of vibration (0.1 mms^{-1}) was recorded during a test which dropped an empty beer barrel on the pavement above the cave. On this basis it was suggested it would be prudent to prevent unloading of heavy goods on the pavement above the cave.

Figures 19 & 20. Vibration monitoring in progress.

All the vibration levels recorded are significantly below the conservative limit of 3 mms^{-1} generally applied to historic monuments.¹⁹ When these results are converted to acceleration (given in g²⁰) even the barrel drop test only yields an acceleration of $0.0137g$. These values are all significantly below the recommended vibration limits for museum collections which vary between $0.2g$ and $0.5g$ ²¹. However as noted by Gibb et al. (2008)²² vibrations at low frequencies will cause greater displacements than those at higher frequencies. From the data shown in Appendix IV the vibrations recorded were mostly at low frequencies and, therefore, may lead to greater movement in areas with existing micro-cracks.

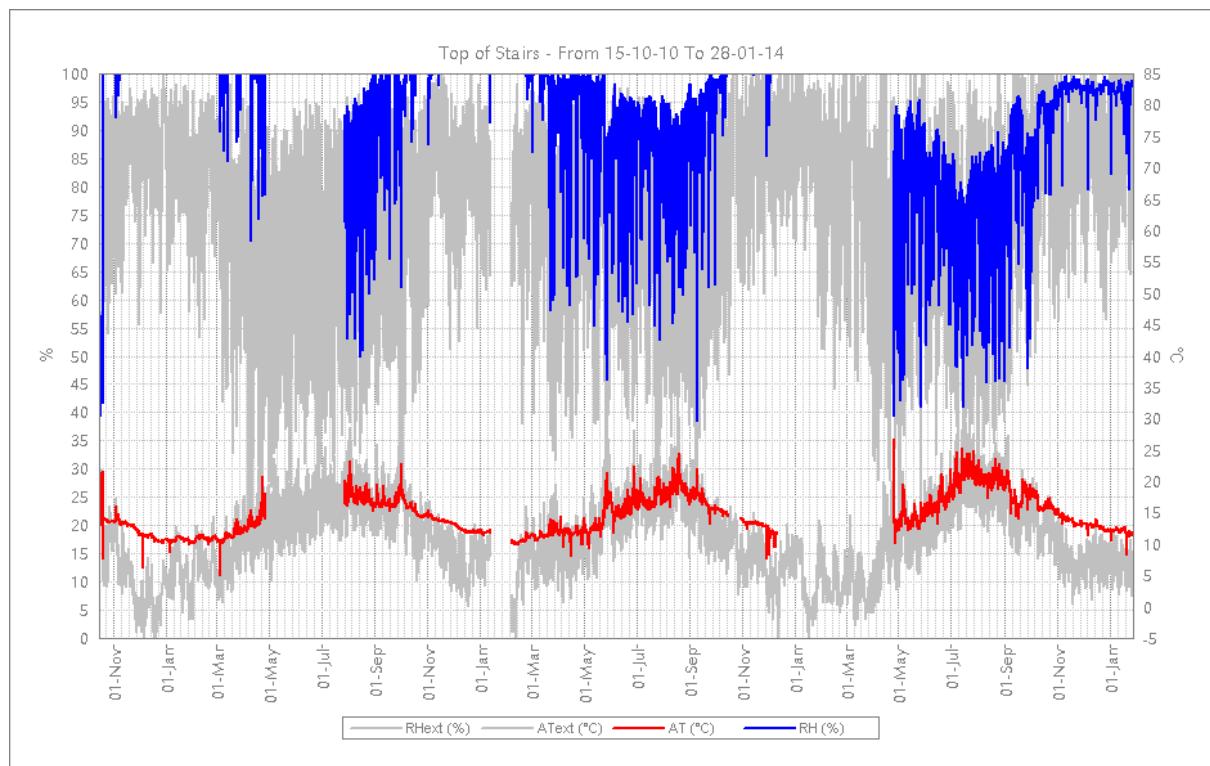
When looking at the data from all the internal monitoring positions the fluctuations are greatest at the top of the stairs, with <3°C daily temperature changes and regular RH fluctuations of <30%. The conditions are generally very similar to external conditions, as might be expected from the position of the transmitter, just inside the external door. This means that during the summer months the RH is much lower at the top of the stairs compared with inside the cave, where it is often close to 75% RH and can be as low as 40% RH. At the same time the low level north side is between 90-100% RH. Winter RH levels are higher, varying between 95-100% RH.

This is a reversal of the trend seen inside the cave, where the summer is higher than the winter. The minimum RH was 38.6%, the maximum 100%, with an average of 93.1%. The temperature range was also greater between 5.1°C and 26.8°C, giving an average of 14.8°C, around 2°C warmer than the average temperatures at other monitored points inside the cave.

Figure 32. AT/RH data for the top of stairs monitoring position inside the cave and external conditions (2011-2013).

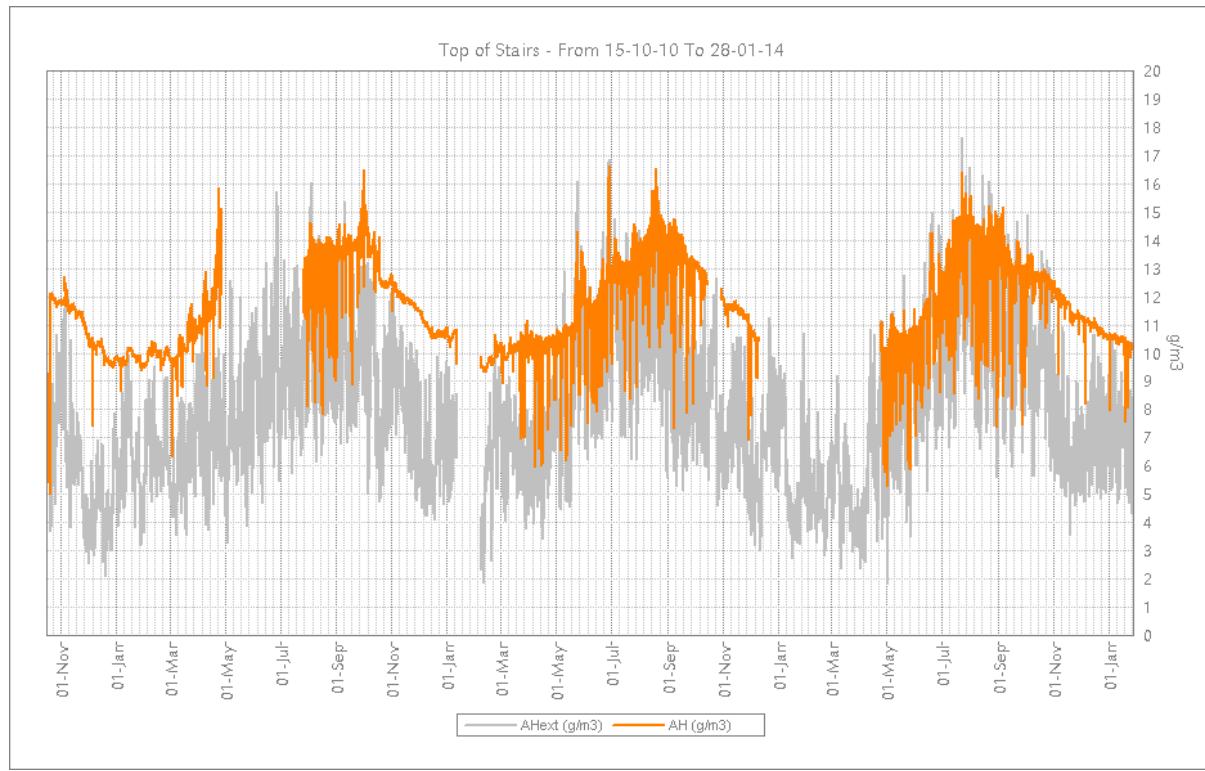
At the top of the stairs the AH follows the pattern of the external environment more closely than at the other monitoring points. The external AH decreases in the summer but remains higher than the external levels during the winter. This gives an average of 11.8 gm^{-3} , very similar to the external average of 11.4 gm^{-3} . While the maximum (16.6 gm^{-3}) is similar to external values, the minimum is higher (5.3 gm^{-3}).

Figure 33. AH data for the top of stairs monitoring position inside the cave and external conditions (2011-2013).

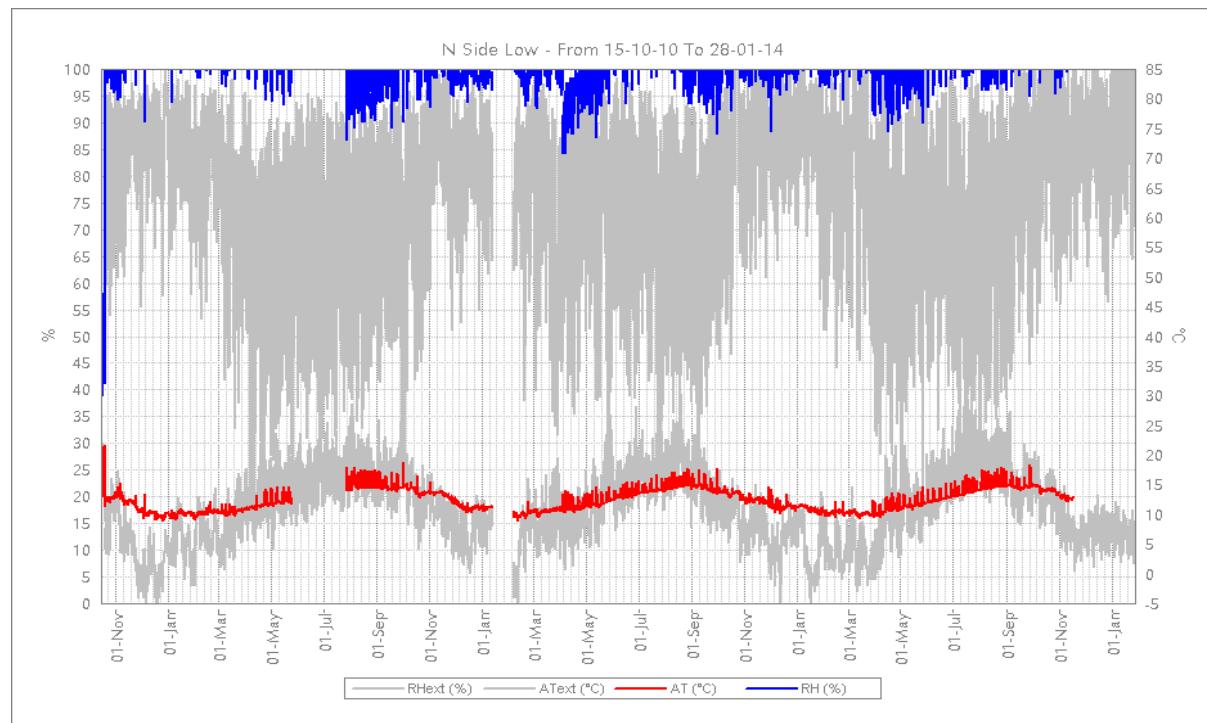
In this lower part of the cave temperature fluctuations change with the presence of visitors, rather than as a result of external conditions. These visitor-induced temperature fluctuations also lead to decreases

in RH. The maximum and minimum RH was 100% and 84.3% respectively, with an average of 99.7% and the RH remains between 90% and 100% almost constantly.

Figure 34. AT/RH data for the lower monitoring position inside the cave and external conditions (2011-2013).

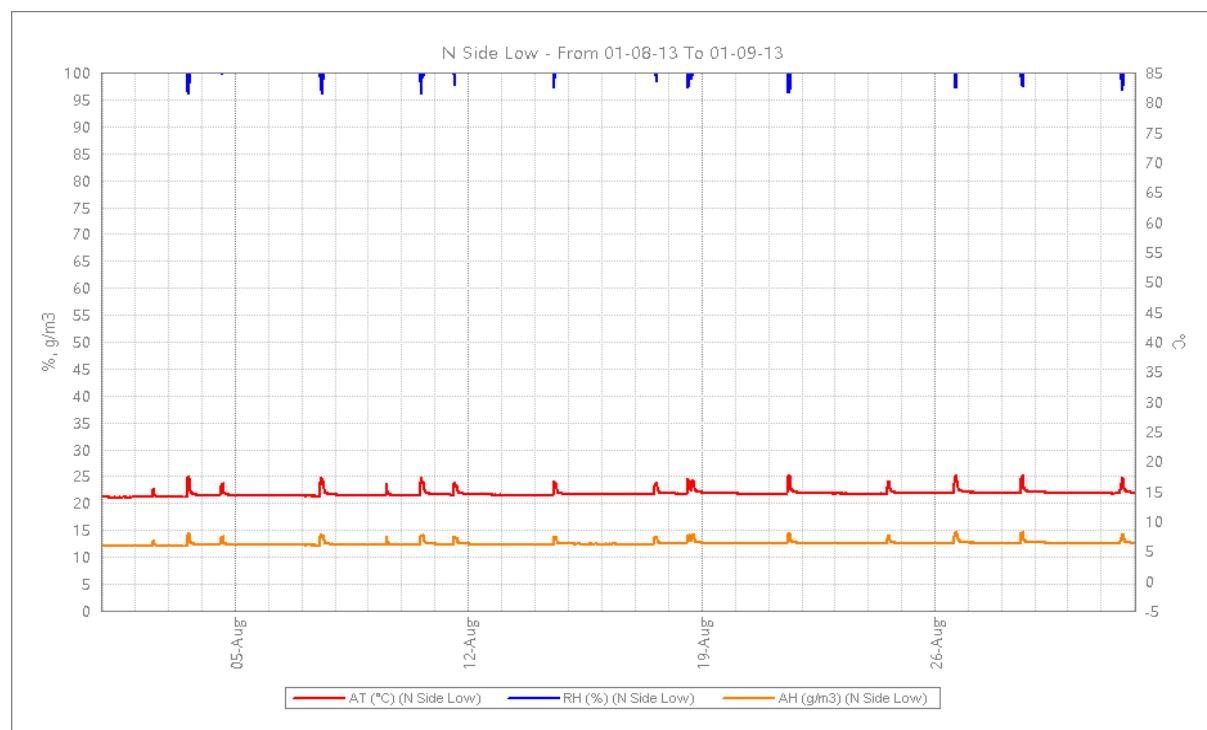
The AH is normally stable with a minimum and maximum of 8.6 gm^{-3} and 14.9 gm^{-3} and an average of 10.9 gm^{-3} . Figure 23 shows that, as with the temperature changes, the AH increases with greater visitor numbers in the cave rather than following external conditions. Open days in the cave are clearly visible, due to the peaks in AH and AT from visitors. This is likely to arise from the sensor being located nearer to the visitors at a height of 1.35m, therefore, their presence has a greater effect on the microclimate recorded locally.

Figure 35. Detail from August 2013 showing the effect of visitors on AH, AT and RH at the lower level of the cave.

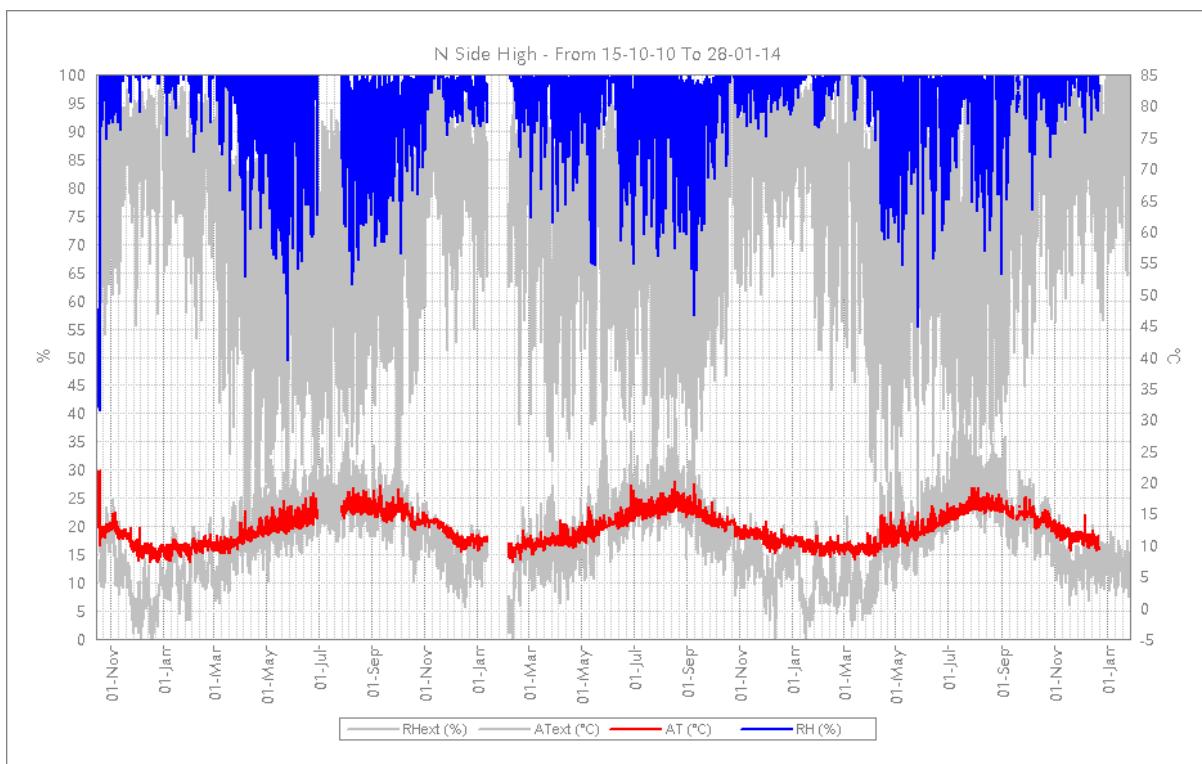
In contrast to the lower sensors, the high level north side conditions are similar to those at the top of the stairs sensors and are affected primarily by external conditions. The chalk still provides thermal buffering limiting the differences between the summer and winter internal temperatures, compared to external conditions. The temperature minimum was 7.3°C, the maximum was 20.3°C and the average was 21.6°C, which are not too dissimilar to the lower sensor. However, more short term daily thermal changes are often recorded compared with lower in the cave. Unlike the lower height sensors, clear patterns of visitors cannot be seen in the data. As the high level north side sensor is placed at a height of approximately 6.2 m within the cave, this is not surprising.

Figure 36. AT/RH data for the higher monitoring position inside the cave and external conditions (2011-2013).

During winter months the RH varies very little in comparison to the summer, remaining close to 100% at the high level north side. From the spring to autumn the daily RH variation is much larger (<40% RH) but with relatively regular daily fluctuations of >20% RH) and closely follows external variations. While the average RH is 96.7% (relatively similar to the lower sensor), the minimum is 49.4% and the maximum is again 100%, showing a wider RH range. The AH closely tracks the higher peaks in AH externally, and follows a similar general trend. However, the internal AH rarely drops to the same extent as the external conditions, with summer decreases in AH never matched. Here the average is similar to the lower sensor 10.8 gm⁻³, however the minimum (6.7 gm⁻³) and maximum (15.8 gm⁻³) again give a wider range. During the winter months the AH remains significantly above external conditions (often twice the external value) and remains relatively constant.

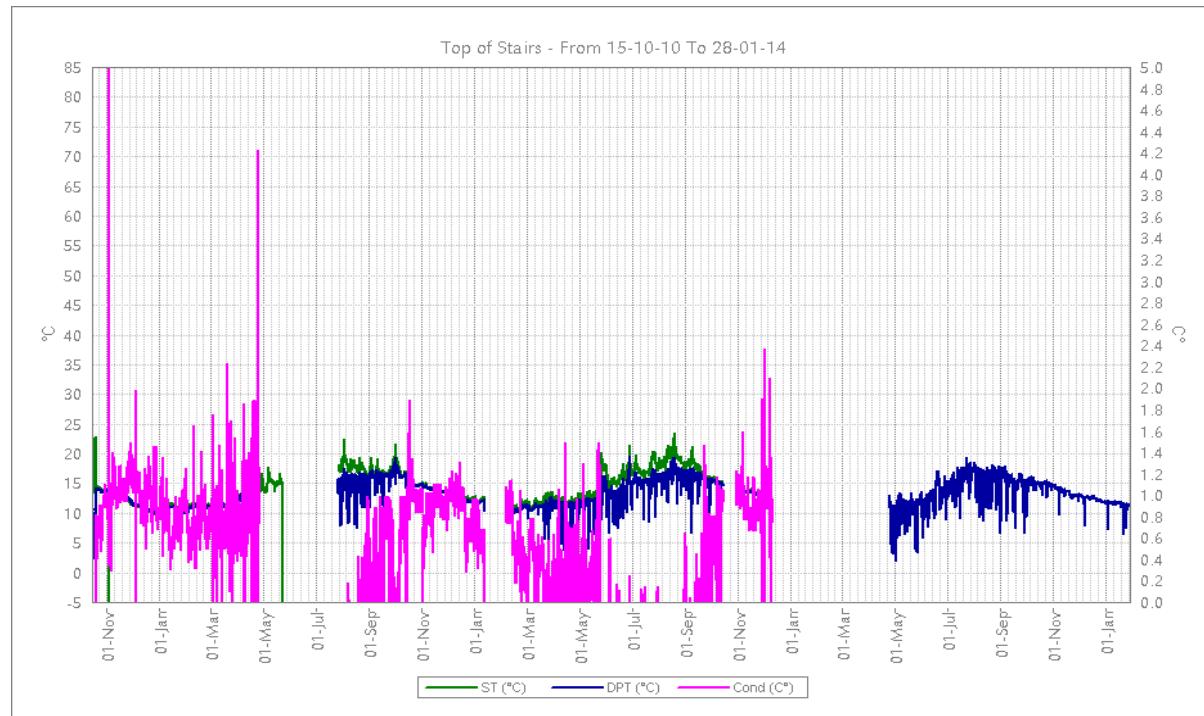
There is less data for the surface temperature sensor at the top of the stairs. However, this shows that condensation is less likely during the summer months where the difference between the surface temperature and dew point temperature is greater. Generally the likelihood of condensation at the top of the stairs increases during the autumn, is greatest in the winter and decreases in spring, showing the opposite trend to that within the cave.

Figure 38. ST, DPT and condensation data for the top of stairs monitoring position inside the cave (2011-2013).

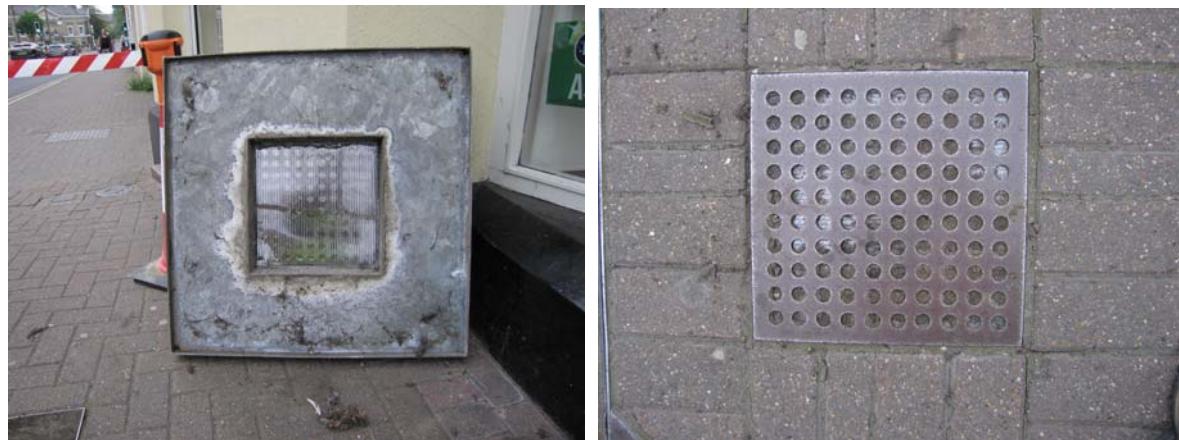
The Stage I condition report¹ indicated the instability in the microclimate may be due to air infiltration from the vent in the cave ceiling. As a result attempts were made to reduce the air infiltration from outside by sealing the ventilation grille in the pavement above. An additional benefit of this measure would be to reduce water and dirt infiltration via the vent.

Figures 39 & 40. Initial tests with complete closure of the vent.

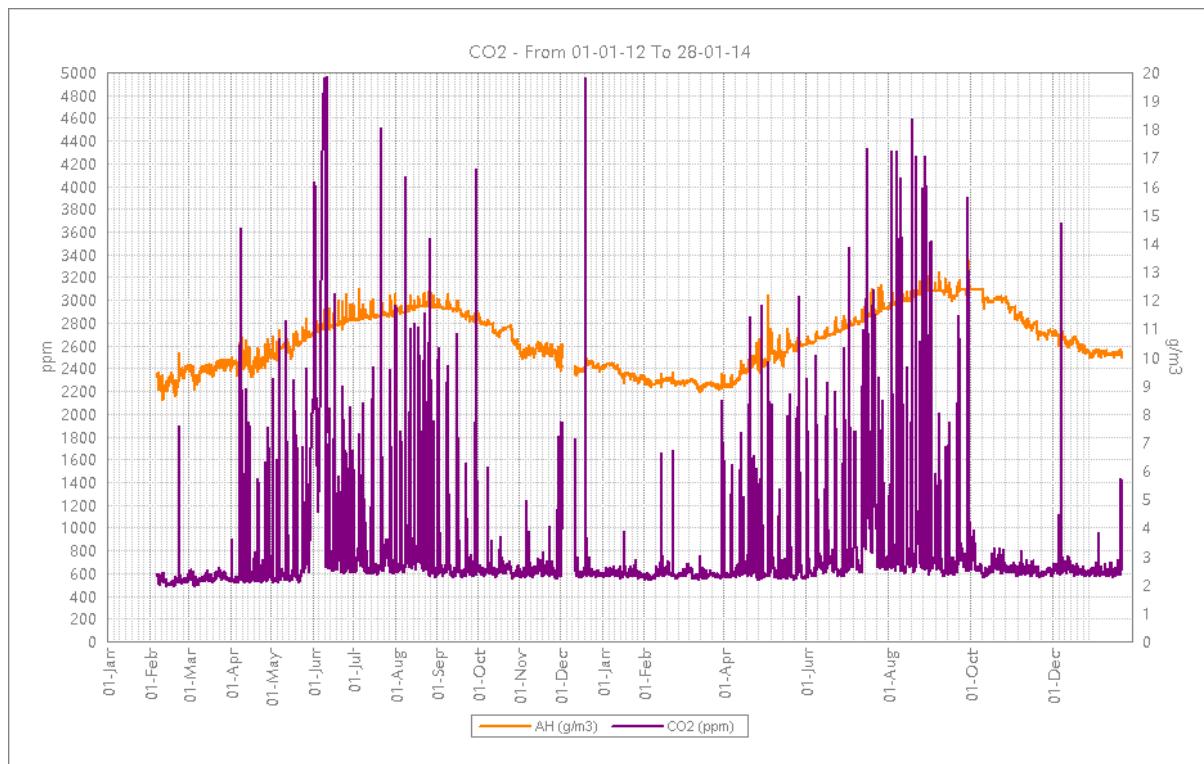
Figure 41. AH and CO_2 data for the CO_2 monitoring position inside the cave (2012-2013).

Once the grille was sealed the CO_2 levels rose to 3800 ppm over the first week and then to 5000 ppm (the sensor limit) in the second week. The long-term workplace exposure limit (8 hour reference period)

As a result of removing the seal it was recommended that a plate be placed beneath the grille to prevent water and rubbish infiltration but allow sufficient air exchange. This would then have to be cleared, probably on a regular basis to remove any accumulated material. As an alternative in April 2013 a filter was added to the vent, consisting of a section of open cell reticulated polyether foam placed over a thin steel wire support.³⁶ While this will reduce the amount of large debris falling into the cave it should not affect CO₂ levels. However it is still recommended that any debris is removed from the filter regularly to prevent blockages from occurring. The filter has the disadvantage of still allowing water ingress via the ventilation grille, but preventing high CO₂ concentrations is more critical in this instance.

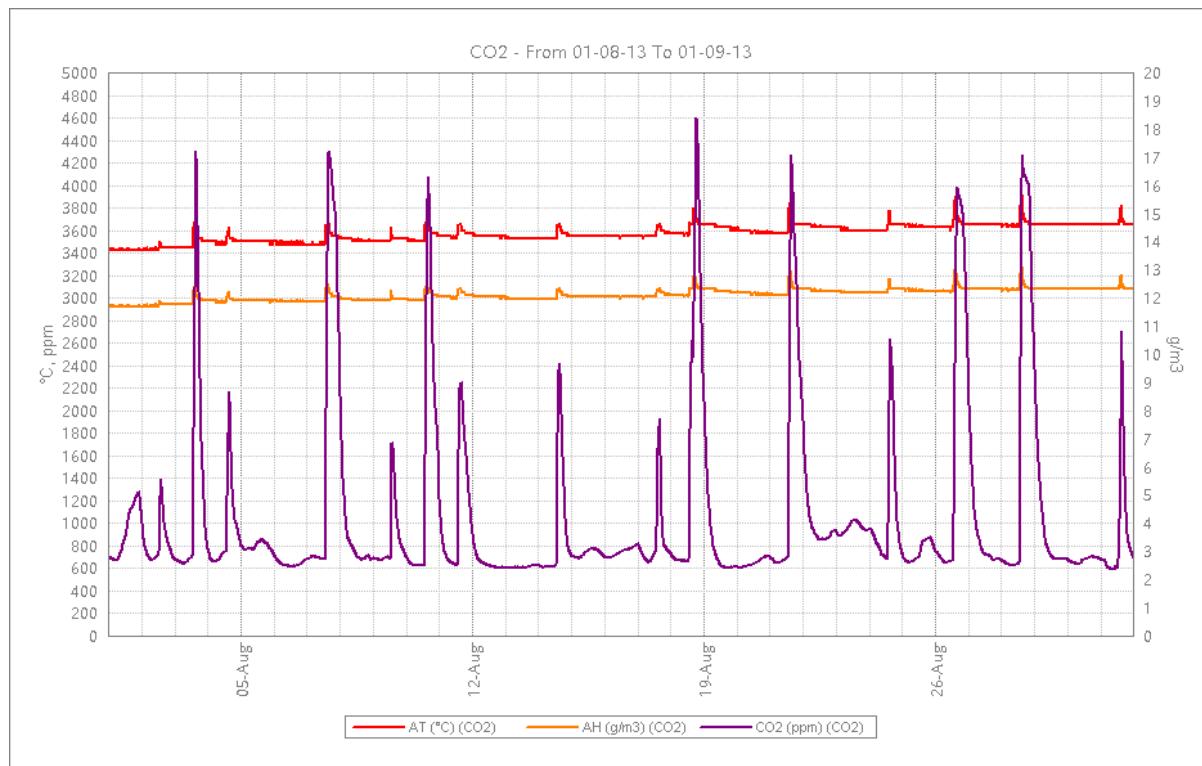
The increases in temperature noticeably reduce the RH. However the reduction in RH is limited by the increase in AH, caused both by visitors expiring water vapour and by vapour evaporating from the walls as a result of the temperature increase.³⁷

Figure 46. Detail showing the effect of visitors on CO₂, AH and AT levels at the CO₂ monitoring position.

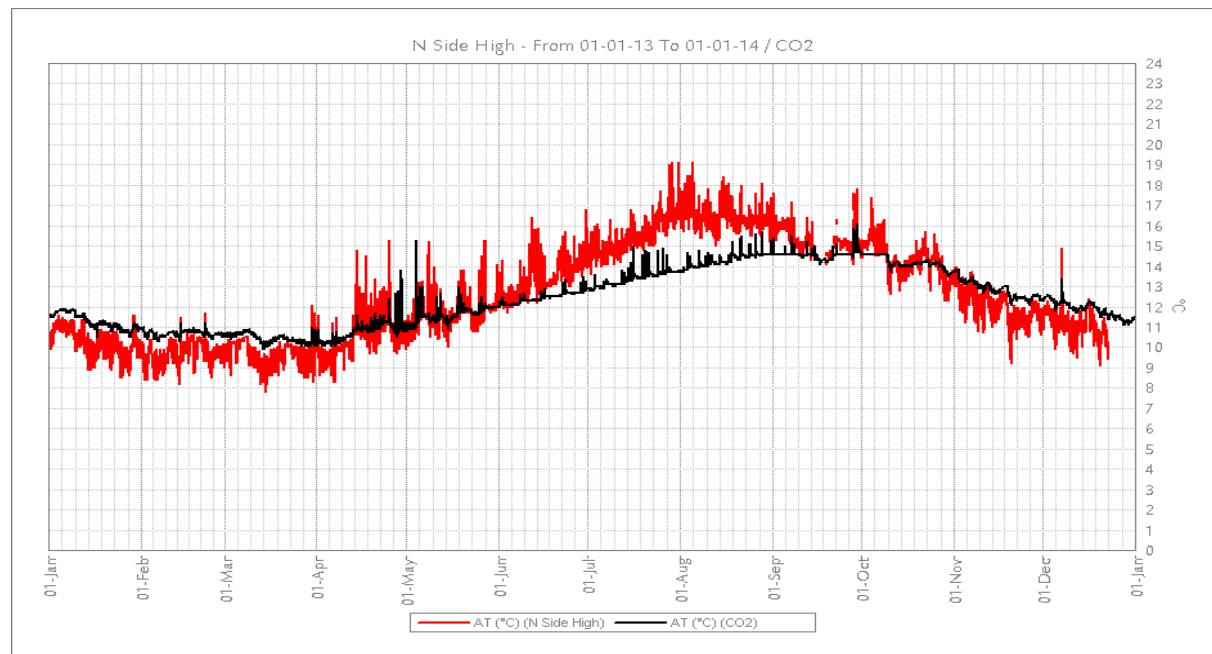
As seen from the monitoring higher up in the cave, this more closely follows external conditions and the environment is much more unstable. One way to determine whether this is occurring would be to measure AT and CO₂ levels at 1m intervals up the height of the cave during the open periods to determine whether stratification and trapping of CO₂ is taking place.

Figure 47. Detail showing the AT difference between the CO₂ monitoring position and the higher location (N side high) inside the cave during 2013.

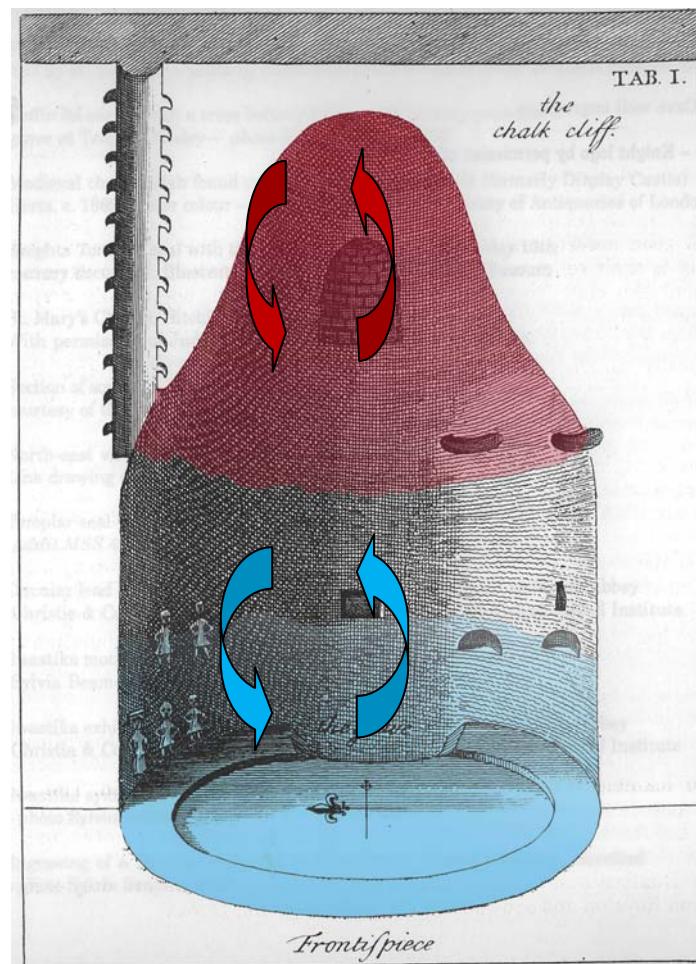
Figure 48. Illustration of thermal stratification within the cave with cooler air (blue) trapped at the bottom compared to the warmer air (red) at the top.
