CONDITION SURVEY AND DEVELOPMENT OF A CONSERVATION PROGRAMME FOR ROYSTON CAVE, HERTFORDSHIRE

REPORT FOR THE FRIENDS OF ROYSTON CAVE

October 2009

Report No: RYC01.1a

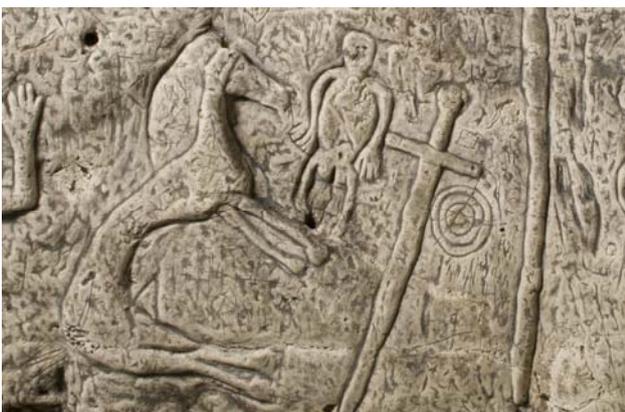
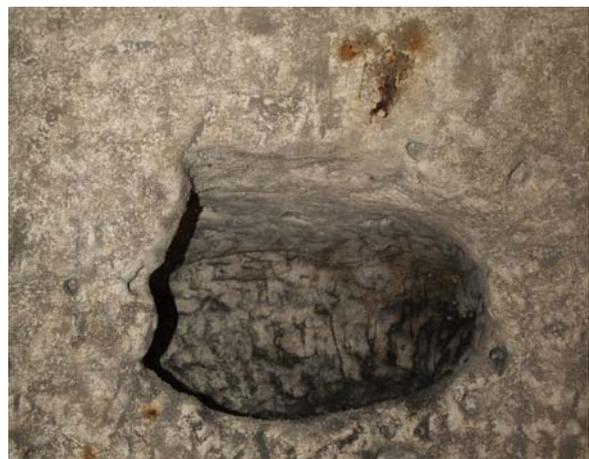
There have been suggestions that the upper part of the cave was also decorated with carvings, but these have largely been lost. There is evidence of a timber floor structure surviving at half height in the cave, but there is little evidence of detailed figurative decoration of the type seen at the base of the cave, although some small incised faces and symbols are present. (Figure 10)

The highly corroded remains of nails were found in a number of areas over some of the openings at half height in the cave. (Figure 11) This appears to suggest that something, possibly a material, was attached over these openings and that they were hidden or closed off. The significance of this is unclear, although it does suggest that some form of ceremonial activity might have taken place at this height in the cave.

Figures 10 & 11 (Above) An incised face at half height in the cave and corroded nails around the openings.

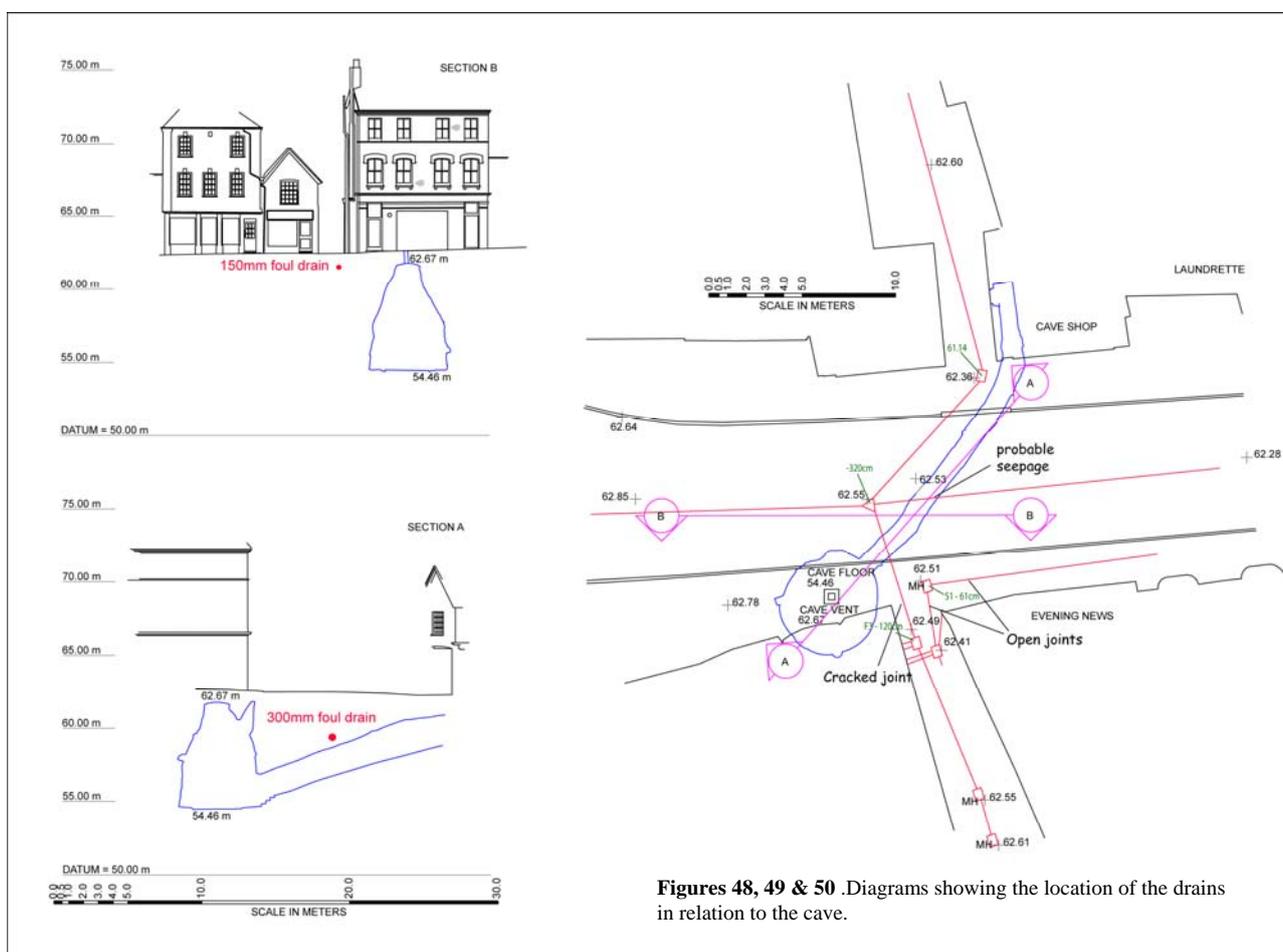
A CCTV survey of the accessible drainage pipes in the vicinity of the cave was undertaken on 01/06/09 and 06/09/09 by Manestream Ltd with instruction from Tobit Curteis Associates. (Figures 48, 49 & 50 and Diagram 11) The aim of the survey was to establish the drainage routes in the vicinity of the cave, their condition, and any clear areas of failure.⁴²

The results showed that there was a main drain, which runs along the centre of Melbourn Street, at a depth of approximately 320cm below road level. This places it at less than 50 cm above the roof of the tunnel, close to the entrance of the cave. The other main pipes run from the courtyard on the north side of the road, next to the entrance of the cave into the main drain in the centre of the road, and from the cul-de-sac on the south side of the road to the same junction of the main drain. These pipes are considerably shallower at approximately 120cm below ground level. All of these pipes are shown on the Anglian Water Services map and appear to be either foul water or combined foul and surface water drains.

Figures 48, 49 & 50 .Diagrams showing the location of the drains in relation to the cave.

The results of the survey showed that most of the pipework was in a condition regarded as acceptable for drainage functions. However, much of the pipework is old and there were general deficiencies and loose joints in many sections, which allow mild seepage. While this is not considered a particular problem in drainage terms, in this particular application, it is more significant than would otherwise be the case. In particular, deficiencies in the main drain, which would allow seepage immediately above the roof of the tunnel is of particular concern.⁴³ Water ingress has been observed in this area in the past and foul water contamination has been suspected due to the odours

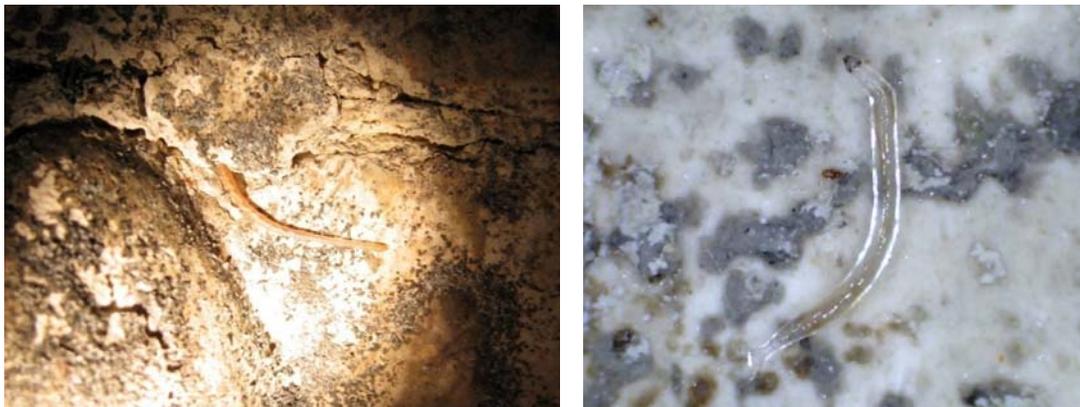
There appear to be two types of worm involved in the deterioration. The larger worm, which is purple and up to 20mm long, has been identified as the brandling worm (*Eisenia foetida*) and is generally found on the lower part of the cave. (*Figure 53*) Higher on the walls there are fine transparent worms, generally less than 8mm long which have yet to be identified.⁴⁵ (*Figure 54*) The damage mechanism to the chalk appears to be broadly the same in both cases, although the scale of the damage cause by the larger worms is obviously greater.

Figures 53 & 54. Macro detail of the brandling worms and photomicrograph (x200 magnification) of the unidentified worm.

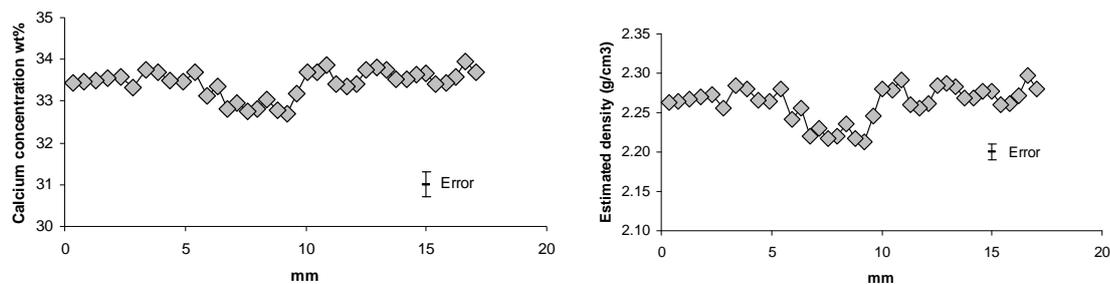
Therefore, EDXA was undertaken on the surface of the sample so that calcium concentrations (and therefore probable density) could be measured. The results showed very little variation in calcium concentration, with only very small inclusions of silicone, magnesium and aluminium, possibly indicating a very low clay content. The density of the material was then calculated on the basis that pure calcite is 40.05% calcium, and the density of calcite is 2.71 g/cm^3 . See figures 53 & 54, below. While this technique does not produce precise densities, it was thought likely that the variation was very little at $\pm 0.05 \text{ g/cm}^3$ throughout the sample. This implied that hard nodules of the type discussed above were not preset on the surface of the sample.

Figure 53 & 54. Calcium concentration and estimated density .

In summary therefore, the cave appears to be constructed of a relatively pure chalk with very little clay or other impurities, and no significant irregularities in density.⁵² It should be noted however, that this was a single sample from a single bedding plain. It is possible that at the edges of bedding plains, and in different plains, the conditions may vary.

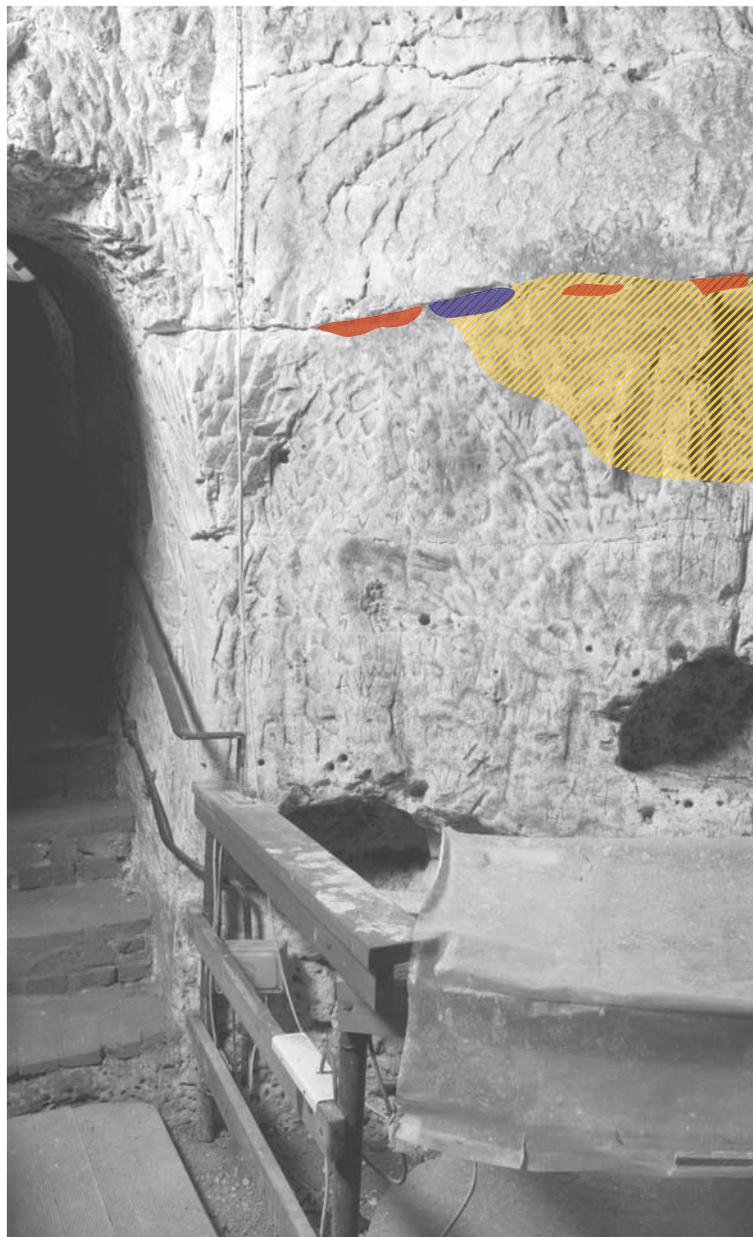
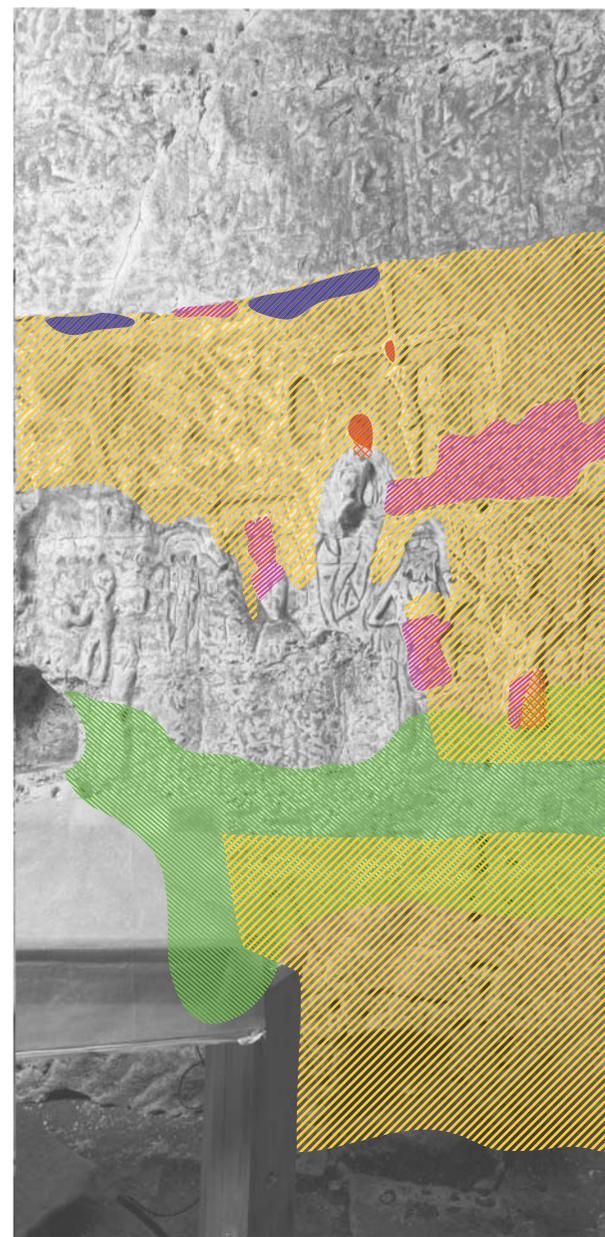
Diagram: 1.0	Site: Royston Cave	Date: June 2009	Scale: Not to scale
	Darkened area of coating		Surface losses since 1997
	Area of delamination and loss		Green MBG 1997
	Present cracking or delamination		Brown surface material
	Cement repairs

It is understood that the structure of the cave is largely stable.³³ There are some areas where sections of masonry are loose, particularly around the edge of bedding planes higher in the cave, and there are numerous historic cracks, both horizontally along the line of the bedding planes, and vertically up the walls of the cave. However these appear largely to be old, and there is little sign of recent movement. (Figure 20 & Diagrams 1 - 6)
